Seaways

The International Journal of The Nautical Institute

Mariners' Alerting and Reporting Scheme

MARS Report No. 260 June 2014

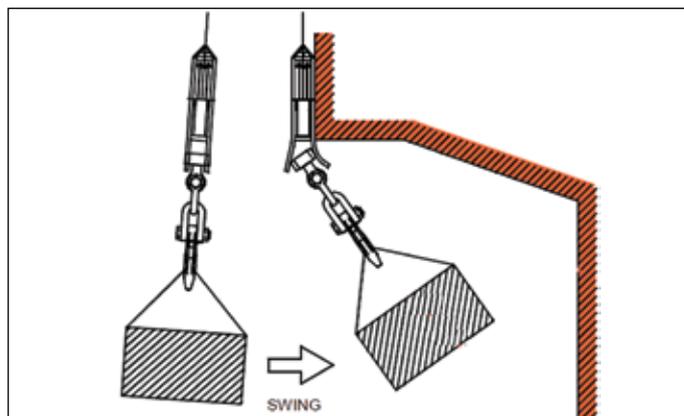
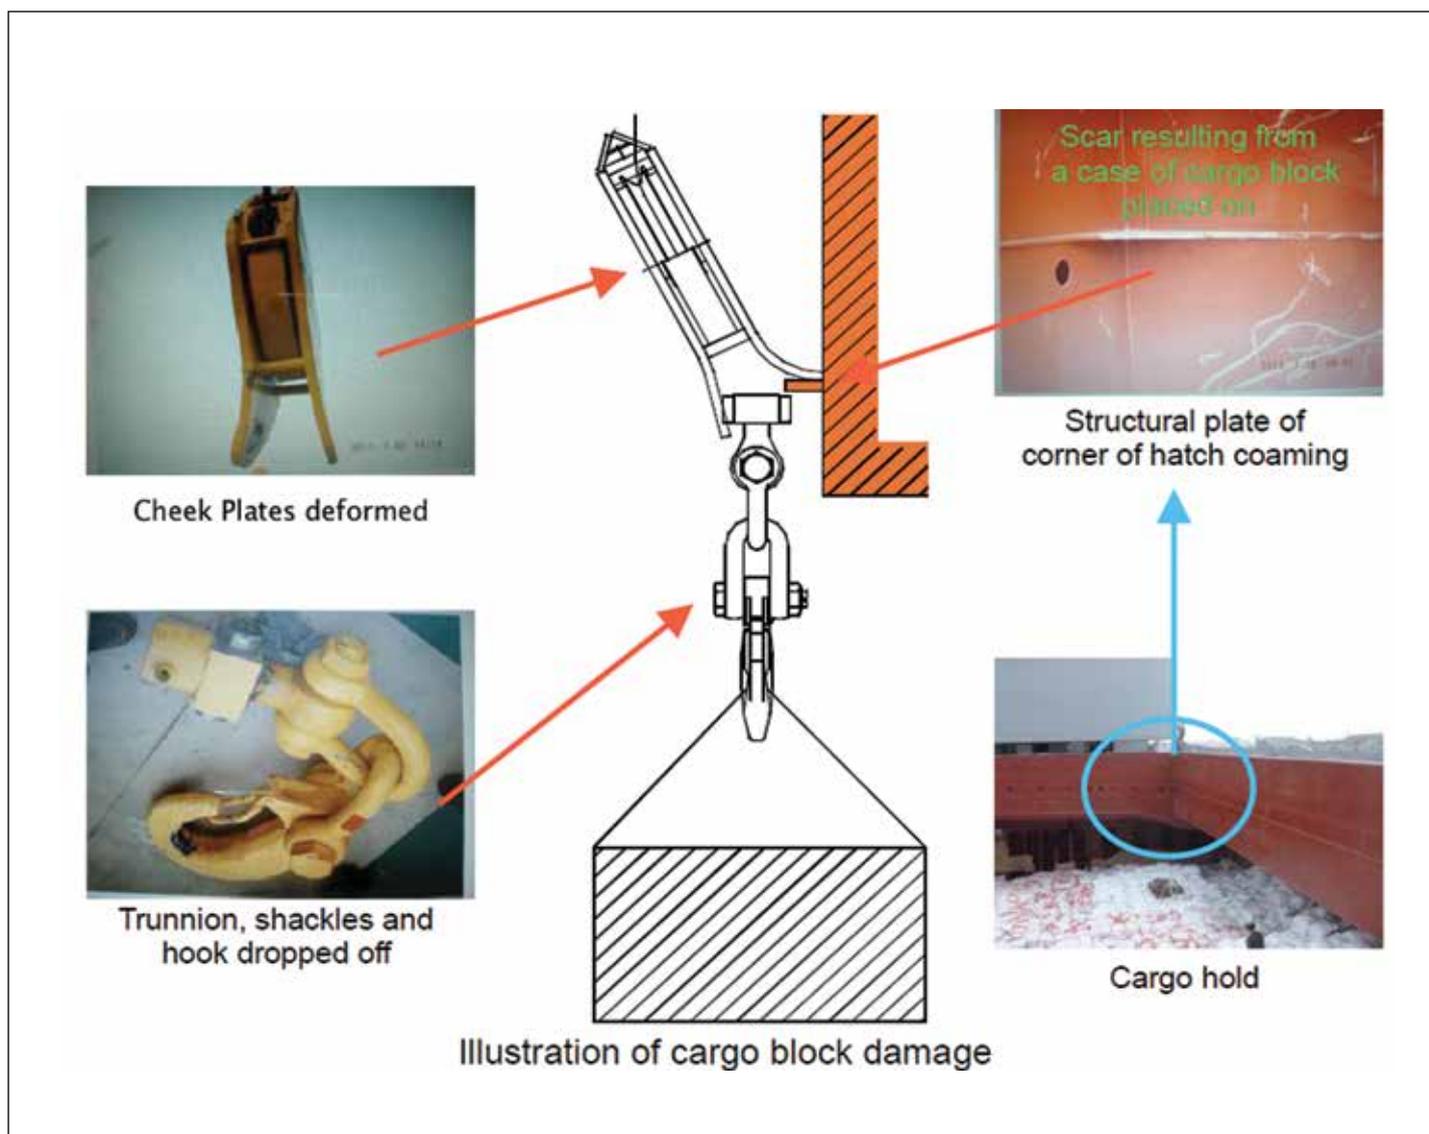
Cargo block opens

→ During various cargo operations, two different manoeuvres have recently caused close calls where the cargo hook and associated equipment have fallen free.

In one, the crane operator continued lowering even though the cargo block became snagged on a structural plate in the corner of the hatch coaming. This damaged the cargo block by opening the cheek plates and could have caused serious consequences.

In the other case, the crane operator swung the lift, which subsequently caused the cargo block to impact the cargo hold. This subjected the cargo block to excessive force and deformed the cheek plates.

- The crane operator should always watch the cargo lift and loose gears carefully, and should not make contact with the hatch or other structures.
- Stevedores should always watch cargo and loose gears carefully during slinging work and crane operation.
- As an added safety measure, the manufacturer recommended reinforcing the block with plates and bolts:

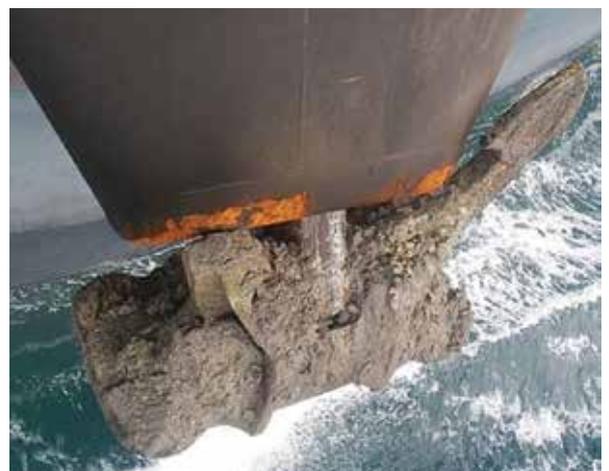
However, during watch handover the 2/O informed the relief that the vessel had dragged about half a cable to the SW. Subsequent monitoring of the vessel’s position confirmed a slow drag but luckily the pilot was due on shortly. As the anchor was lifted the bosun informed us that one fluke was missing. Everyone was amazed that a fluke from an anchor weighing 10,500kg had been broken in such benign conditions.

Once the anchor was on board everyone was very surprised to see the condition of the steel. Incredibly, we even found small pieces of rags trapped by some cement or plaster within the cast metal. A few weeks later, after the suspect metal had been analysed in a laboratory and a follow-up investigation done, we were informed that some anchors produced for the shipyard where our vessel was built had casting failures so bad that they were ‘corrected’ prior to final inspection and delivery to the shipyard.

■ **Editor’s note:** Even at a safe and benign anchorage a watchkeeper must always be vigilant and check the vessel’s position often. Also, use your anchor alarm if so equipped. Anchors and chains, even relatively new ones, can break at any time due to bad assembly or manufacturing faults.

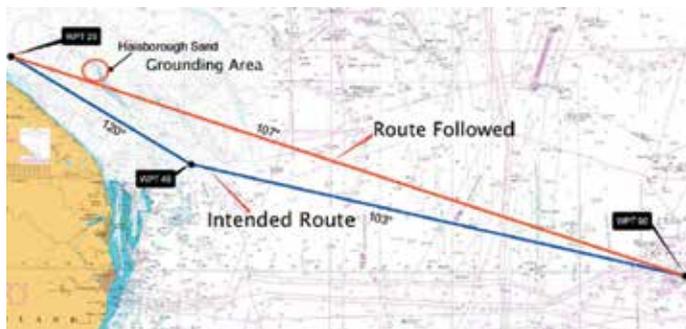
→ A small general cargo ship was in ballast and bound for Amsterdam, the Netherlands with a speed over ground (SOG) of approximately 7.5 knots. At 2355, the chief officer took over the bridge watch from the Master, both sharing the watch-keeping duties using a 6-on, 6-off routine. At this time the vessel was on autopilot and heading 110°. An AB was also on watch but he was told by the chief officer that he was not required on the bridge so he returned below. The vessel was rolling in the rough seas and the chief officer predominantly remained seated, monitoring the vessel's progress against the navigational track on the radar. During his bridge watch, the chief officer completed some administrative tasks on the ship's computer but did not plot the vessel's position on the paper chart. At 0256, the vessel's speed decreased rapidly as the vessel started to take the ground. Soon after, the chief officer had put the main engine to full astern but the vessel was now stationary. The Master was quickly on the bridge and moved the engine telegraph to stop. He noticed the GPS was indicating that the vessel's position was close to the track on the display. He also noticed that the destination was waypoint 90, not waypoint 48 as he had expected. The Master plotted the position displayed on the GPS receiver onto the paper chart and thus confirmed that the vessel was in very shallow water on Haisborough Sand.

- The vessel departed from the intended route because the waypoint selected as the destination in the GPS did not follow the sequence of waypoints detailed in the voyage plan.
- The chief officer did not notice that the vessel had deviated from the intended route because he relied solely on GPS and did not verify the course the vessel was following or plot the vessel's position on a paper chart.
- The chief officer probably fell asleep for an extended period; he was alone on the bridge and the bridge watch alarm was switched off.

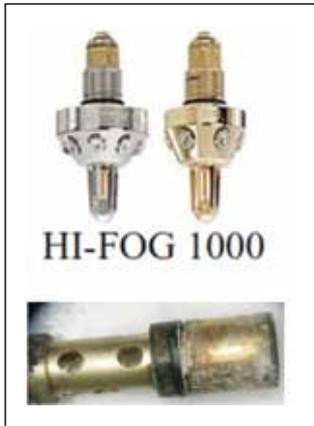
→ A 1600 GT vessel built in 2006 was fitted with a MARIOFF high pressure water mist fire suppression system throughout the vessel. At a routine maintenance and test programme, 22 of the 'wet pipe' system sprinkler heads were found to be faulty and would not have operated had the system been activated in an emergency. A photograph of a typical head is shown, with an example of a contaminated spindle.

- The manufacturers had issued a bulletin in June 2012 identifying risks of contamination of the spindles and heads due to poor water quality, but this was not appropriately disseminated or shown on their web site. Water dosing and testing was recommended.
- The manufacturers had issued a second bulletin, also in June 2012, recommending that at least two heads from each section

- IMO MSC.1/Circ.1432 does provide some guidance on this issue.
- It is considered that there is a high risk that the system will not work as required in an emergency unless all sprinkler systems, including the water within the system, is correctly maintained and tested.

- The manufacturers had issued a third bulletin in May 2013 recommending increasing the standby water pressure from 25 to 40 bar to ensure that the spindles were operated when the system operated. Again this appears to have not been appropriately disseminated.
