# Seaways

# Mariners' Alerting and Reporting Scheme

MARS Report No. 265 November 2014

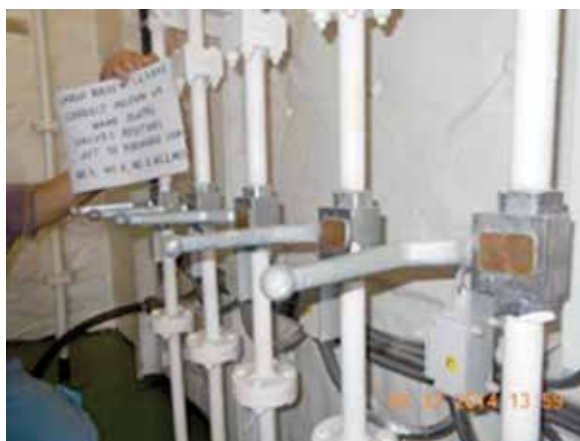
During fire safety equipment verifications, the fixed CO<sub>2</sub> cargo hold line identified as number five hold was tested by blowing compressed air into the system line. Despite this, no air passed through to the other end located at the forward and aft hatch coaming of number five hold. The CO<sub>2</sub> line's air drain in the engine room was checked and found to be in order. The CO<sub>2</sub> pipe aft of hold five was dismantled to check for any clogging but none was found. Again, compressed air was blown through but there was no air arriving at the exit end.

Further investigation found that in the CO<sub>2</sub> room, the identification for the release valves for holds one, two, four and five were mis-identified. Only hold number three was correctly identified. As it turned out, the system was mis-identified upon initial installation from right to left instead of from left to right. Hence, only hold number three was correct, the others being in reverse order, and the error had not been caught.

Testing for the proper operation of the CO<sub>2</sub> system is to be thoroughly conducted including physical check of outlets, not just cursory test or simply paper documentation for compliance.

Proper communication with personnel involved in the test must be established in order to confirm which valves are opened and that the release valve and lines match the labels on the information plate in the CO<sub>2</sub> room.

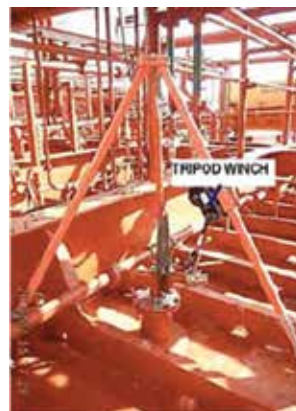
Three crew were in the process of overhauling a tank cleaning machine for one of the cargo tanks. At the end of the overhaul the cleaning machine was being repositioned in the hold using a tripod winch. As the inlet housing of the cleaning machine was being lowered in a controlled manner using the tripod winch, one of the crew inserted his fingers under the flange to retain the O ring in its groove as it kept slipping out of position. The inlet housing was approximately five cm off its final resting place when the winch, clamped on tripod leg, suddenly and unexpectedly moved. This caused the inlet housing flange to drop on the middle finger of the crewman's right hand causing deep lacerations.

- Inadequate engineering; the clamp holding the winch slipped on the tripod leg causing the suspended load to trap the crew's finger.
- Retaining the 'O' ring in the groove using fingers is incorrect practice. In such cases, it is good practice to use Loctite (or similar) to maintain the correct position of the 'O' ring in the groove of the flange.
- Lack of thorough risk assessment prior to undertaking the job.

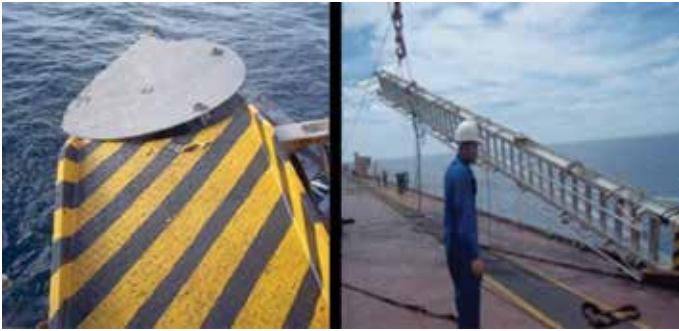
the procedures for stowing the accommodation ladder in its seagoing position. Suddenly the hoist wire broke, letting the shore-end of the ladder fall. The ladder was now only attached to the ship by the main ramp. The vessel's speed was reduced and the cargo crane was used to retrieve the ladder and place it on deck.

The wire was found to be in generally good condition and had been recently greased. Records and related photos indicate that inspection and maintenance intervals had been followed. The wire was almost two years old and was without indications of rust or defects along almost all of its length. However, it was observed that the point where the wire broke had more rust and less grease than elsewhere. After further investigation using the wire layout it was found that the break occurred at a point where access is difficult, thus rendering maintenance and greasing more arduous and less efficient. The wire at this particular point is continually exposed to sea/weather conditions yet can be less well maintained than the rest of the wire. Additionally, when the ladder is about to be stowed or deployed these same wire parts experience the maximum amount of tension.

1. The wire was already wasted at the roller positions, which are always exposed to sea and weather. Given their location, these two points are hard to access for verification and maintenance.
2. The ladder's limit switch may have been bypassed during the operation.

1. All vessels' accommodation and pilot ladders should be checked for vulnerable points and wastage.
2. Instructions should be given to vessels on how to treat the wires on these accommodation ladders.
3. Crew should be given instructions on the use of limit switches and how they help protect the wire from excessive tension.
4. The accommodation ladder manufacturer should be informed of the weak design.

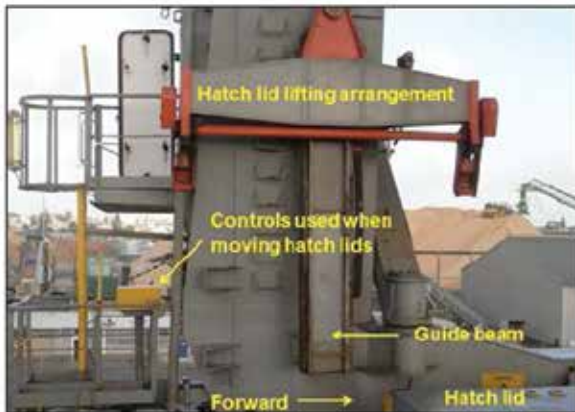
At the time of the accident, this hatch lid was double stacked on another lid. The little clearance between the guide beam on the aft leg of the gantry crane and fittings on the hatch lids is even further reduced when they are double stacked. Each gantry crane was fitted with warning devices that operated automatically whenever the gantry crane travelled along the length of the deck.

**Hatch lifting assembly and guide beam shown next to a single stacked hatch lid**

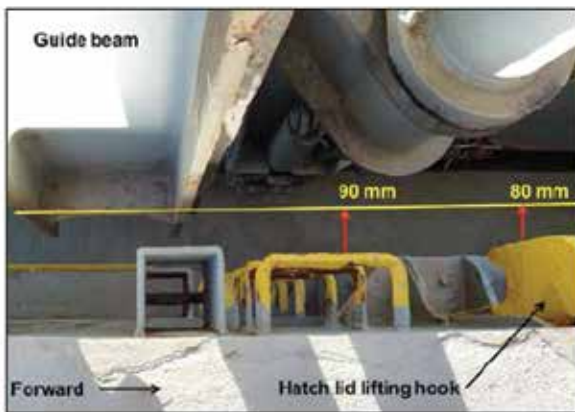
**Guide beam shown next to double stacked hatch lid.**

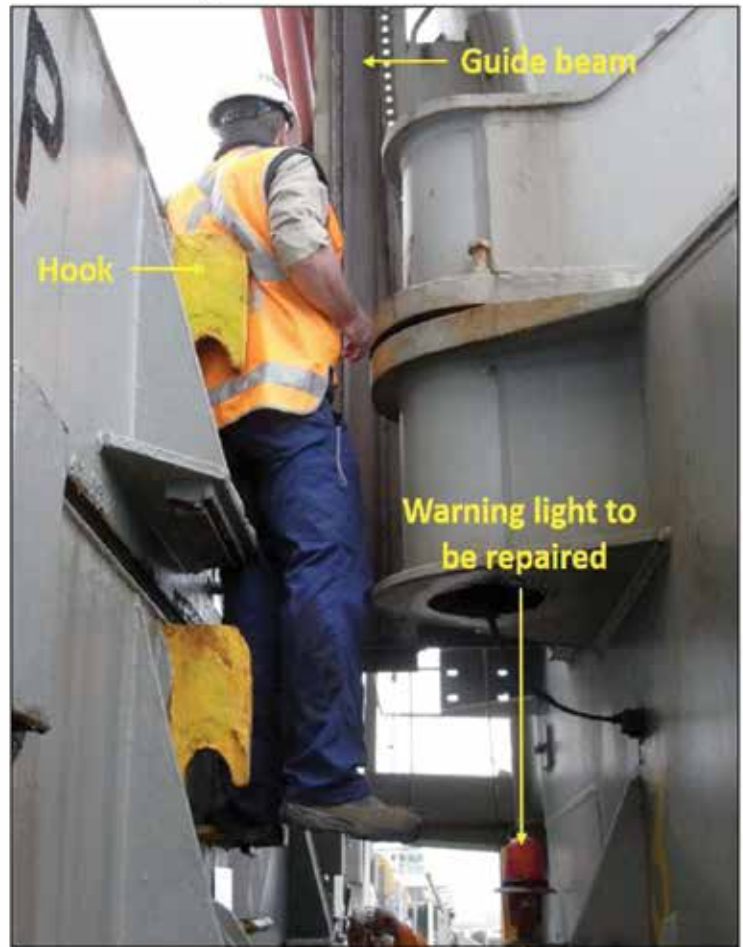
The vessel was in port and routine 'travelling manoeuvres' of the vessel's gantry crane by a ship's officer were being undertaken. The assistant electrician, probably standing near the top of the hatch access ladder, was caught and fatally crushed between the hatch lifting hook and the guide beam of the moving gantry crane.

**Likely position of the assistant electrician.**

The gantry crane 'in motion' warning light nearest to the assistant electrician's location was not operating and the warning sirens were not audible from his location. As a result, he was not provided with either a visual or audible warning of the crane's movement.
