Seaways

Mariners' Alerting and Reporting Scheme

MARS Report No. 273 July 2015

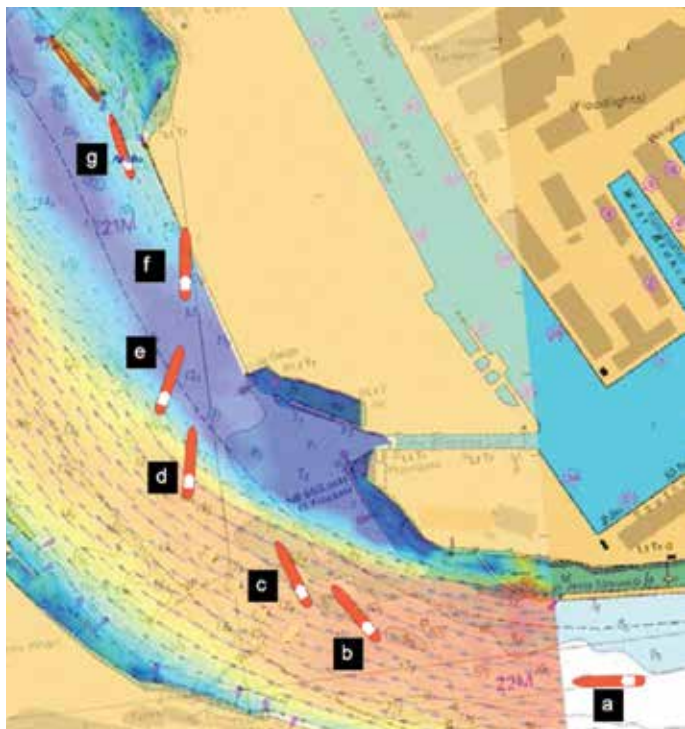
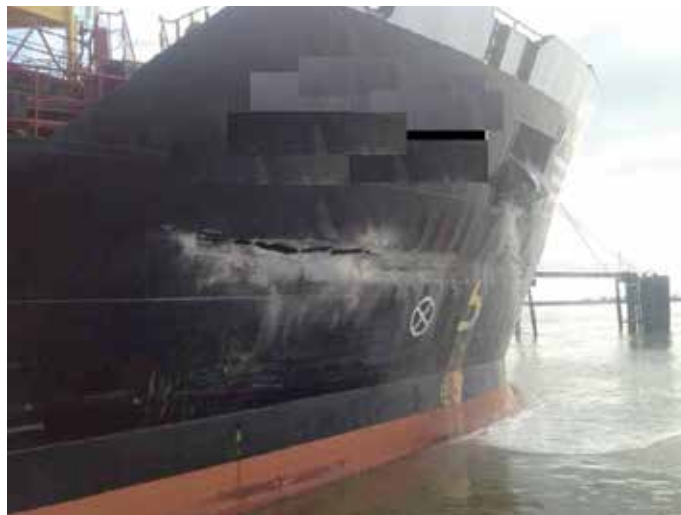
After about four hours pilotage, tugs were ordered in preparation for berthing. The vessel was approaching a starboard turn in the river, with a flood current astern, when the pilot ordered the helm to starboard 15°. Within 30 seconds the vessel's rate of turn was 25°/min to starboard. Soon afterward, as the vessel was rounding the turn the pilot ordered the engine stopped (point C in diagram below); for just over 30 seconds the engine was at stop before dead slow ahead was ordered. However, the vessel's head was still swinging rapidly to starboard.

The pilot ordered full ahead, hard to port (point D) and requested one of the tugs to assist. The vessel was about 100m from the shore when its bow began to turn to port. The Master had just returned to the bridge and he repeated the order of full ahead, hard-to-port. Shortly thereafter the pilot ordered full astern, but the vessel's starboard bow made contact with the quay nonetheless at a SOG of 6.0 knots.

- The pilot was unaware that the vessel was equipped with a controllable pitch propeller (CPP) drive.
- Although indicated on the pilot card, the reference to CPP was not easy to find on the form. The format of the card was poor in comparison with the layout considered best practice, such as that outlined in the International Chamber of Shipping (ICS) Bridge Procedures Guide.
- When a vessel fitted with a CPP is moving ahead and the pitch is set to zero, the flow of water through the propeller and across the rudder is interrupted and steerage will be adversely affected.

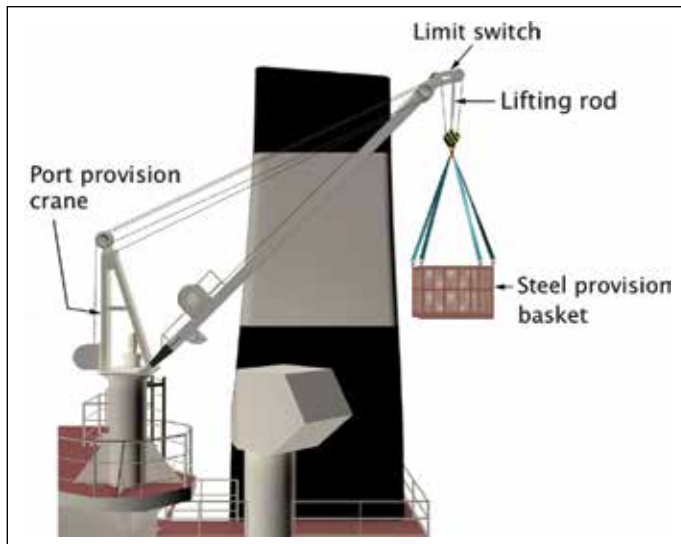
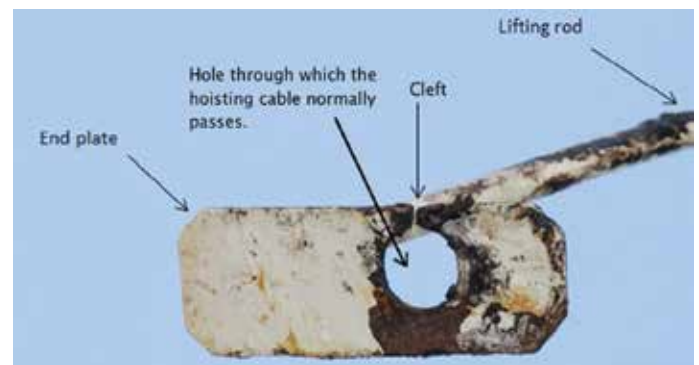
from the basket that the bosun was manoeuvring towards the deck. As the officer walked towards the spot where the paint had spilled a snap was heard. He looked up and then stepped back at the same moment the basket containing the bosun came crashing down approximately five metres, landing directly in front of the officer. Immediately following the accident, the crew members removed the bosun from the basket and administered first aid but he was later declared deceased.

- Although the crane was not suitable for lifting personnel, it was nonetheless being used to work aloft.
- Although bench tests showed the limit switch to be operating normally, it did not cut power when the crane block exceeded the set limit. Most probably the lifting rod and wire were not properly rigged; the cable not fitted through the hole in the lifting rod’s end plate. In this situation, the unsecured lifting rod would have been pushed aside by the crane block, rather than up, and the limit switch would not have been activated.

- The bosun’s view of the crane block was obstructed from the position inside the basket, limiting the bosun’s ability to identify that the block had exceeded its set limit.
- The crane block made contact with the underside of the boom and the winch continued to pull, causing the hoisting cable to part and the basket to fall approximately five metres.

- It is very tempting to use a provision basket to transport crew to hard to reach maintenance areas. But, if the basket has not been certified for transport of personnel it should not be used.
- Attention to detail is important – in this case a vital safety device (limit switch) was rendered useless by a faulty installation.

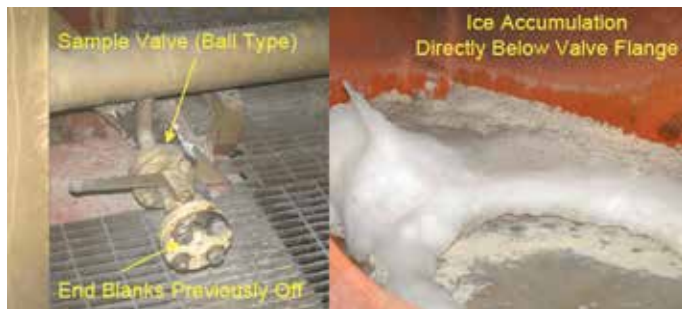
It was reported that while this system was operating, the piping near the expansion valve began constricting flow due to freezing hydrates. This then caused an increase in system pressure from the expansion valve back via the condenser and to the outlet of the compressor.

It appears probable that the drains at a sample point were left cracked open, or just leaking, to allow hydrates to escape. In any event, significant accumulations of ice were noted in the bilge areas below the same sample point for two of the three liquid line drains. A hazardous flammable atmosphere was therefore allowed to develop and a spark of unknown origin ignited a fire near the condenser. It was extinguished quickly by a crew member using handheld dry chemical extinguishers.

It is likely that unsafe cargo handling procedures associated with manual draining of hydrates from the drain line on the outlet of re-liquefaction condensers directly contributed to this casualty.

Routine and frequent training should be given to shipboard officers and crew based on documented procedures; in the case of LPG vessels it should cover such topics as;
