Seaways

The International Journal of The Nautical Institute

Mariners' Alerting and Reporting Scheme

MARS Report No. 282 April 2016

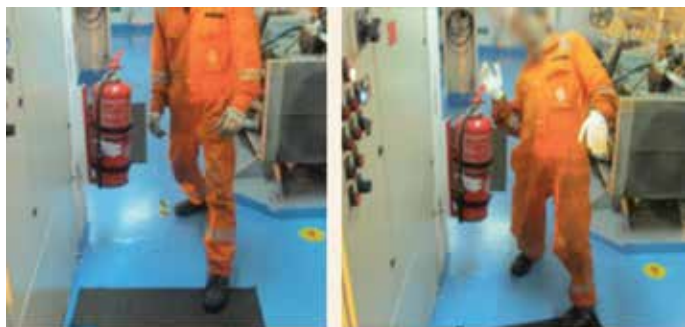
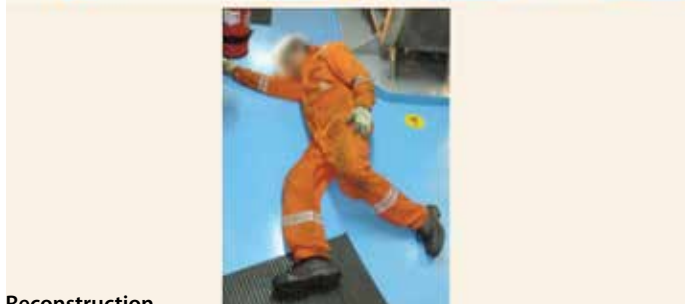
Reconstruction

While an oiler was on his usual rounds and near the air compressor the internal telephone system sounded. He quickly proceeded towards the engine control room to answer the call; as he stepped on the insulation mat in front of the main air compressor breaker panel the mat slipped under foot and he fell. After examination it was determined that his shoulder had become dislocated.

The company investigated the incident and has since removed the mat from service as the underside was worn and not gripping properly. All other mats have been checked for their grip and wear.

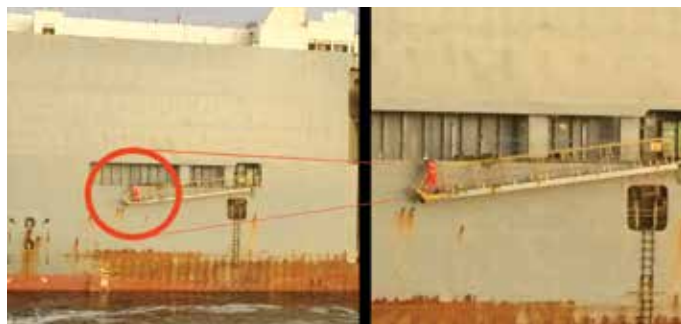
→ The car carrier was leaving berth and the deck crew were at various tasks about the ship, securing lines and bringing in the gangway among other things. One crewman was at work securing the gangway. Working alone approximately seven metres above the water, without a life vest or lifeline, he secured the railing posts prior to bringing the gangway up to its stowed position.

No unwanted consequences were known to be forthcoming – but an unsafe working practice was observed.

- Unsafe working practices can creep into our daily routine by the very fact of their commonplace nature.
- When working over the side one should always wear a life jacket.
- Working alone while over the side virtually guarantees your death if you should fall in the water as no one will know you are in the water.

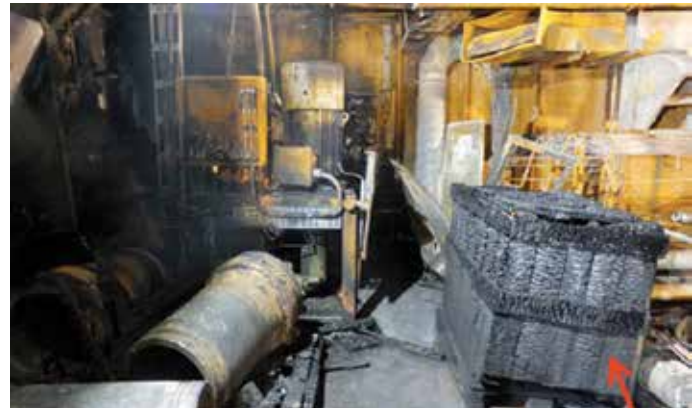
- While the hi-fog system was able to tackle the fire in the immediate vicinity of the two main diesel engines, the fire was able to spread outside of this area. Combustible materials, including wooden packaging, that were located near the source of the fire were a contributing factor to the spread of the fire.

Combustible materials stored near source of the fire

- A specific risk assessment should be done in every engine room to determine the potential for, and protection from, oil under pressure reaching hot surfaces.
- Keep engine rooms as clean and neat as possible with combustible materials stored away from possible sources of ignition.
