Seaways

Mariners' Alerting and Reporting Scheme

MARS Report No. 283 May 2016

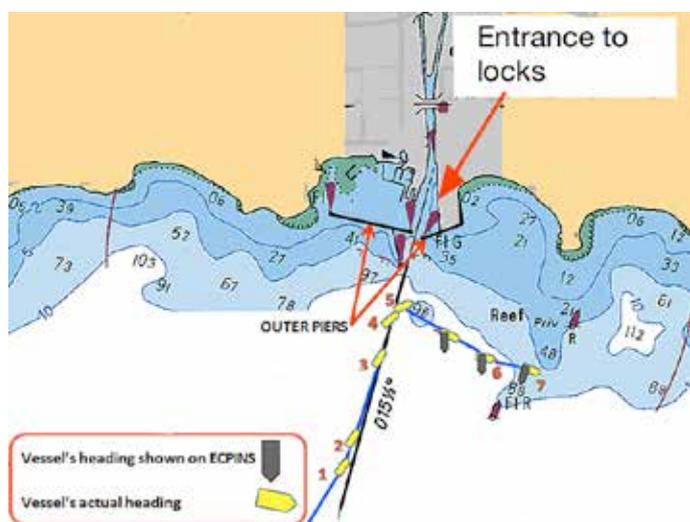
A few minutes later, the Master looked at the ECPINS slave monitor and noticed that the vessel's course made good was easterly, but that the vessel-shaped marker that indicates the heading was pointing southerly. He requested the magnetic heading from the helmsman, who reported it to be 111° magnetic (M). The Master looked outside and saw that the shoreline was on the vessel's port side, instead of on its stern. He immediately ordered the helm hard to starboard to correct the vessel's course and increased the propeller pitch to get more power ahead. The vessel began turning to starboard but, moments later, the hull touched bottom and the vessel ran aground 1.5nm southeast of the lock outer piers (number 7 in diagram).

- A number of power failure alarms on the bridge created a situation that resembled a blackout and was interpreted as such.
- Engineers responded to the developing situation by applying the vessel's blackout procedure twice, which caused additional power interruptions to the bridge; however, the engineers were unaware that these actions were having this effect.
- The power interruptions on the bridge, combined with the vessel's turn to starboard, caused the gyrocompass to become misaligned.
- Following the power interruptions the Master was (unknowingly) using inaccurate data from the ECPINS. Additionally, he was not using all available bridge resources to monitor the vessel's progress for nearly 15 minutes before the grounding.

- Electronic charts are a wonderful navigation tool that give real-time situational awareness. But these instruments can also be a trap that is easy to fall into. Use all means at your disposal, especially visual means if possible, to confirm that what you are seeing on the screen is in fact reality.
- The gyro compass is one of your best friends. Always check on its accuracy, especially after a blackout or electrical interruption.

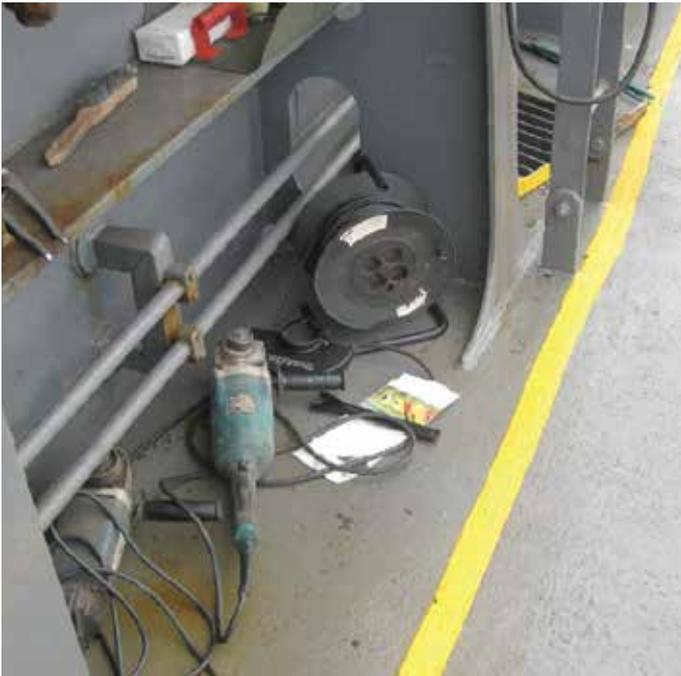
→ The vessel was *en route* to a European port. Deck maintenance was in progress, including repairs to a stand located at the cargo hold hatch covers. During the cutting of a steel bar using a portable grinder, the cutting disc suddenly broke into pieces. Part of the cutting disc (or possibly the steel bar) hit a nearby crew member near his right knee area. The wound was about 5cm long and 2cm deep and pieces of loose bone (or cartilage) were observed in the wound.

- A grinding disc had been used instead of a cutting disc.
- The grinder did not appear to have its protective cover attached.
- Grinding wheels are subject to deterioration if stored in damp or humid conditions. The effects are a reduction in bond strength caused by the ingress of moisture; this affects the balance and causes surface growth, which reduces the bursting speed.

- Grinding and cutting discs should be discarded after three years storage as physical deterioration during this period may render the disc unsatisfactory.

- Always use the right tool for the task. In this case, a grinding disc was being used for cutting.
- Never detach or render ineffective safety devices such as protective covers – they are there to protect you.
- Grinding and cutting discs, among other power tools, operate at very high speeds. Make sure the various parts and consumables are in top-notch condition and of reliable quality.

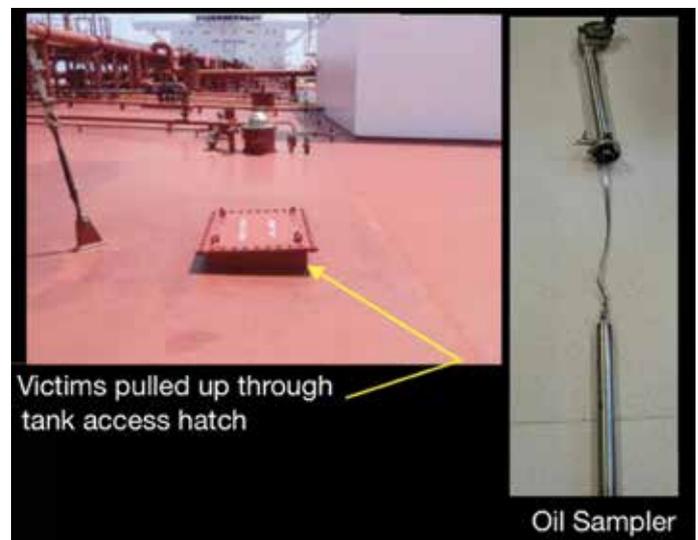
➔ While discharging an oil cargo from a tanker, an oil sampler (similar to that shown in the photograph) was lost to the bottom of tank 3P. It was decided that once the discharge was finished and crude oil washing completed, the sampler would be retrieved before loading the next cargo into 3P to avoid any potential damage to the ship's equipment from the sample bucket or tape.

- Normally, inert gas is introduced into the tank to drive out the hydrocarbon content (purging) to below a level out of the flammable range before replacing the inert gas with fresh air (gas freeing – ie HC to be at 2% or less). It is not known why this procedure was not carried out in this instance.
- With a HC level of 26% LEL the atmosphere was too rich to allow an explosive condition, but was also too high to support a tank entry without BA gear.
- The rescue tripod was not made ready at the tank access hatch.

- An emergency escape breathing device (EEBD) should be used only for escape from a compartment that has a hazardous atmosphere and should not be used for fighting fires, entering oxygen-deficient voids or tanks, or worn by fire-fighters.
- Always follow procedures, as not doing so could have deadly consequences.
- Never shrink from politely questioning a colleague or even a superior about a work practice if you think it is unsafe.
