Seaways

MARS Report No. 284 June 2016

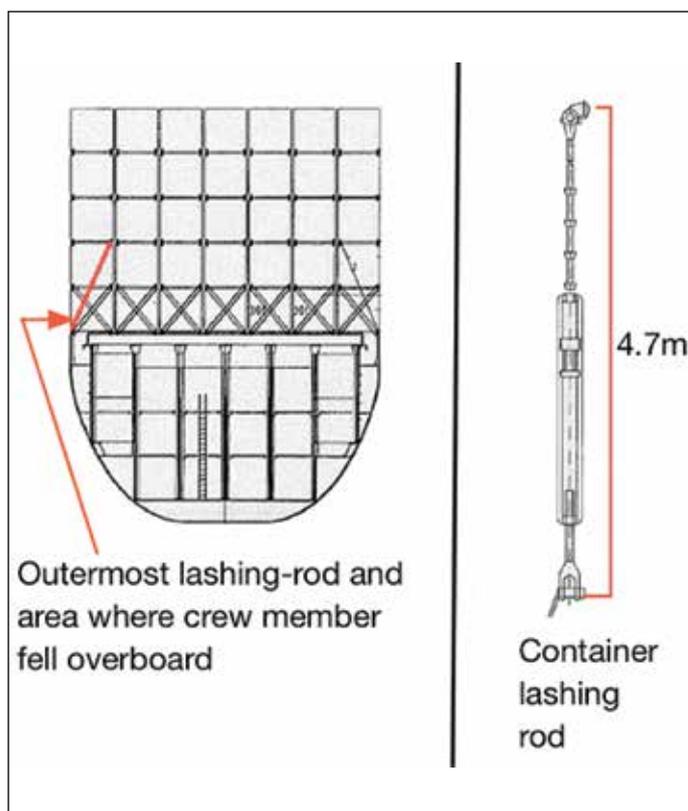
→ A container ship was underway under pilotage in a confined waterway en route to a berth. Some crew were removing the lashing rods in preparation for discharge once berthed. One of the seamen removed the outermost long lashing rod (4.7m long) and was seen balancing with it upright in his hands. He was briefly in balance, but then both the lashing rod and the seaman went over the side.

Apparently, it was a regular practice on board, although not written down in procedures, to remove the interior lashings before berthing but not the outermost ones. It is unknown why the crew member did not adhere to this practice.

■ **Editor's note:** In this casualty the victim did not adhere to the practice of removing the outermost lashing only once the vessel was at berth. That practice, albeit unwritten, was a barrier (or defence) to reduce risk. Yet, even if he had adhered to this practice and all other factors remained the same, he would have fallen overboard nonetheless.

The lashing, at more than 4m in length and quite ungainly and heavy, was situated in a dangerous position near the ship's side. It may be worth considering whether this particular task should be done by two people instead of one.

- When working close to the side or at height, always wear a safety harness.
- If there is a risk of falling overboard, wear a lifejacket.
- Unwritten work practices should be formalised into written procedures and the relevant risk assessments carried out to ensure risks are as low as reasonably practicable (ALARP).

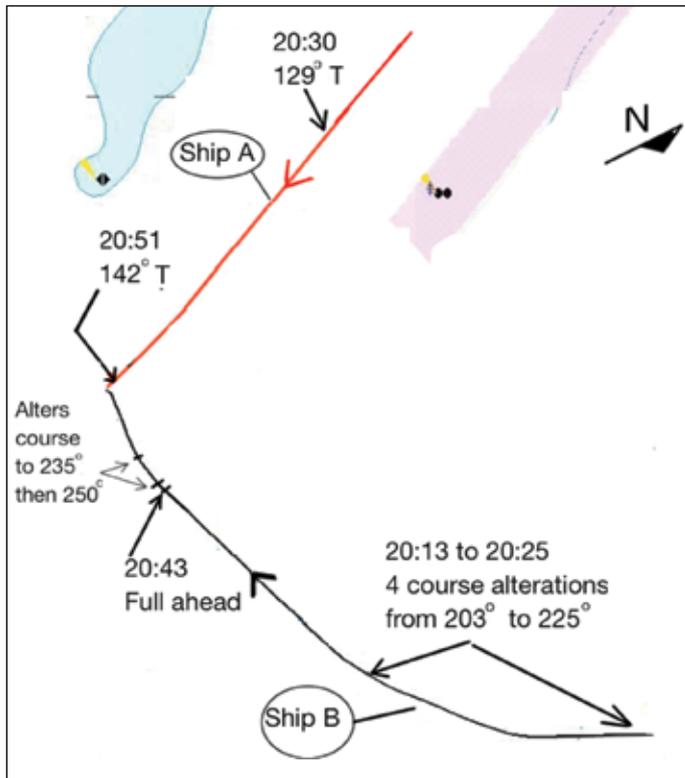
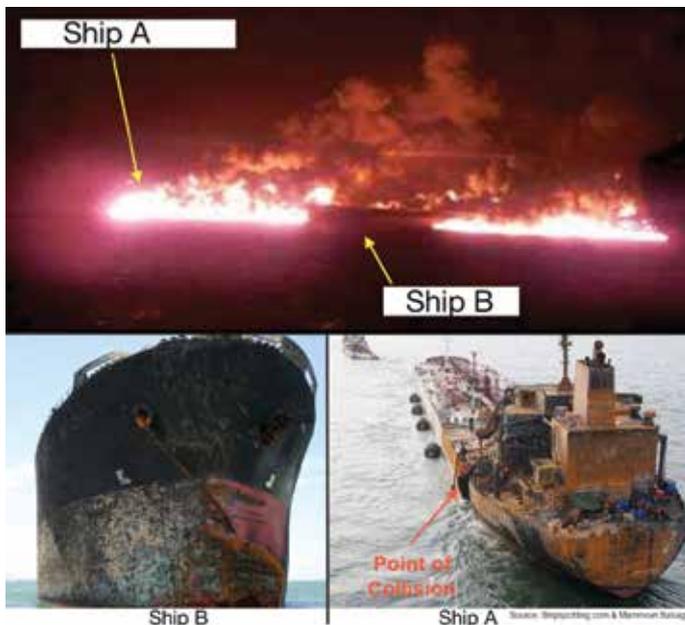
A massive explosion occurred on Ship A as a cargo tank ruptured and naphtha was spilt and ignited. The ignited spill engulfed the sea surrounding the two vessels.

On Ship A, nine crew members were killed and other crew members injured. Three crew members were injured on board Ship B. Both vessels incurred substantial fire and structural damage as a result of the collision.

- Both vessels were proceeding at full speed at the time of collision, yet one of the safest of time-proven tactics is to slow down when unsure of the developing situation or of the intentions of the opposite party.
- Keep the bridge clear of chit chat and business unrelated to navigating the ship when in high risk areas, high traffic areas or at all other times when maximum concentration is needed.
- Course alterations should be as bold as possible so as to make your intentions known to the other vessels.
- When two ships in your vicinity collide and explode, do your best to stay safe but also render what assistance you can to the fellow mariners involved. Do not sail away as if nothing had happened.

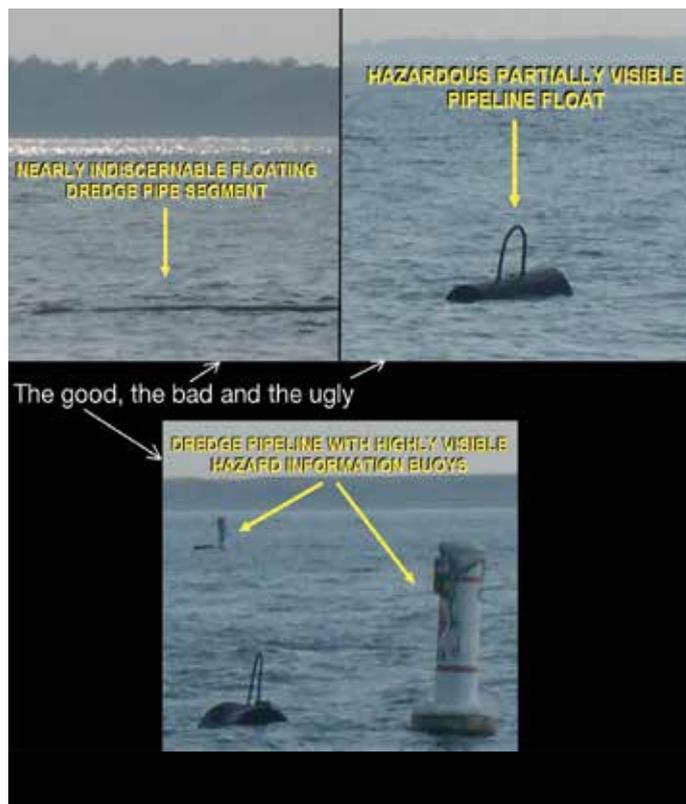
➔ Often, dredgers and dredging operations use floating pipes as a means of discharging collected silt and sand. Some dredge discharge pipes are made of high-density polyethylene. Although they are generally buoyant and float, they do so in a mostly submerged manner.

Accidents in the past have been caused by unmarked or improperly marked segments of dredge piping strings and equipment, or unretrieved piping near busy waterways and unmarked piping. Unwanted consequences, especially to small craft, have included extensive damage to hulls, shafting, rudders and keels but also injury and death to crew and passengers.

- Commercial entities performing dredging in waterways should ensure all components of pipelines are properly marked and accounted for regardless of the recreational boating season and locations where dredging is taking place.
- Proper lights and shapes should be displayed on floating gear in accordance with the applicable regulations.
- Commercial ship traffic and pleasure craft should keep a sharp lookout when navigating in areas where dredging operations are taking place.
