The International Journal of The Nautical Institute

# Mariners' Alerting and Reporting Scheme

MARS Report No. 285 July 2016

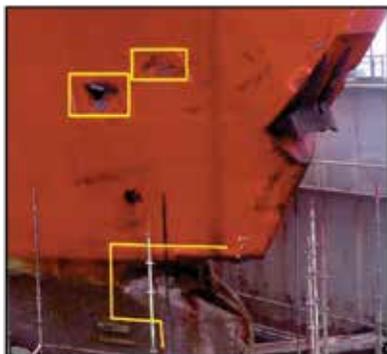
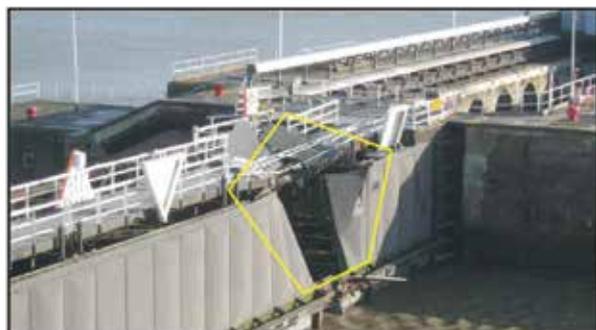
Damage highlighted in yellow

Less than two minutes after losing control of the speed, the vessel rammmed the lock gate at a speed of somewhat more than four knots. All the propulsion units were immediately switched off and a damage assessment initiated. Among other damages, the forepeak was punctured and the ship lost some of her buoyancy. The lock gate was also heavily damaged.

The Master initiated the sternward manoeuvre by turning both azimuth control levers 180°. In doing so, he must have assumed that both control consoles were in manual mode. But the starboard propulsion was still in autopilot mode, which meant that the starboard propeller held its position at 0° due to the tiller being at midships; any thrust from this propeller consequently sent the ship forward. The unintended forward thrust of the starboard propeller took effect immediately but the required sternward thrust of the port propeller was delayed due to the azimuth drive having to turn 180°.

- Even when bridge team management appears to be working well there could be hidden weaknesses. In this case each person was working in his own 'bubble' and when it came time for quick reaction the Master experienced a slip – he activated the starboard propeller as if it was in manual mode.
- When working as a bridge team, practise verbalising all of your actions as this helps memory and lets the other team members know what is happening and what you are doing. In this case, had the team verbalised the mode of each propeller in the initial stages of the manoeuvre, the Master may have avoided his subsequent slip.
- Assumptions can be dangerous. Check and double check your instruments.

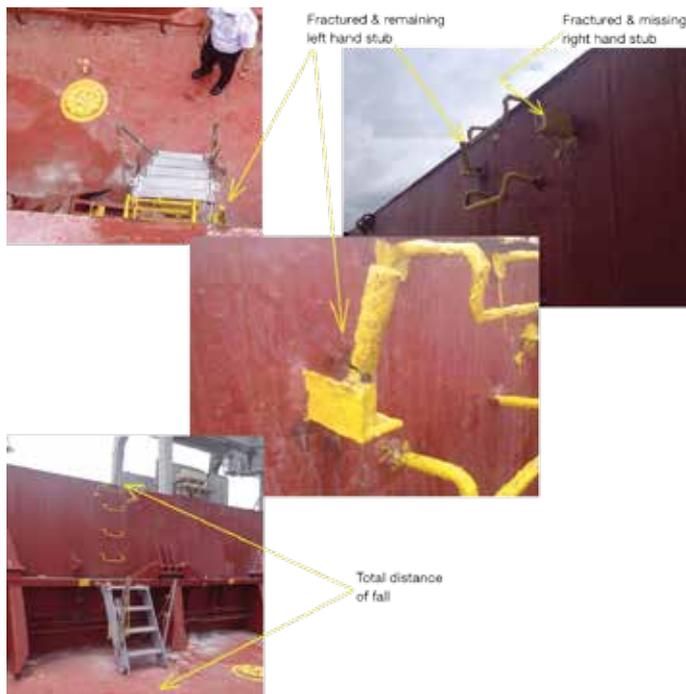
In instances where handholds and stanchions are fitted, other deficiencies have been noted. Recently, while the pilot was holding the stanchions to descend a hatch coaming, both the stanchions and the stub posts into which they were fitted gave way due to severe corrosion (see below). The pilot fell backwards to the deck some 2.5 metres below. His 'flying helmet' probably saved him suffering extensive head injuries when his head hit the deck.

- Just as much attention must be given to the detail, safety and quality of helicopter landing areas as to traditional access via the vessel's side.
- Safe helicopter access is not just an issue for pilots, but could be critical for crew or rescue workers in an emergency situation.

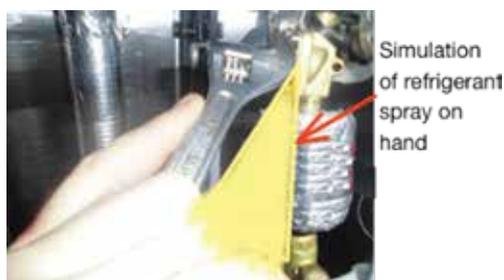
While he was inspecting the solenoid valve of the refrigeration gas lines using a wrench, refrigerant gas suddenly released and sprayed on his hand.

The company investigation found, among other things, that there had been a failure to complete a permit to work. The permit to work was necessary due to the fact that work was to be done on a line presenting a hazard. This first failure probably contributed to a second dangerous act, that of not wearing proper personal protective equipment (PPE), in this case gloves. Also, the normal lock-out/tag-out procedure was not followed as the inlet and outlet valves were not closed prior to the work and pressure was maintained within the lines.

- PPE such as boots, gloves and glasses should be second nature in a truly safety conscious work environment.
- Permits to work are not just a paper exercise, but contain valuable checklists to help crew members stay safe.
- Consulting the Material Safety Data Sheet (MSDS) for the material to be worked on should become second nature.
- While every crew member is responsible for following procedures, safety leadership is also an important element in the system. In this case both sides of the equation were less than adequate.

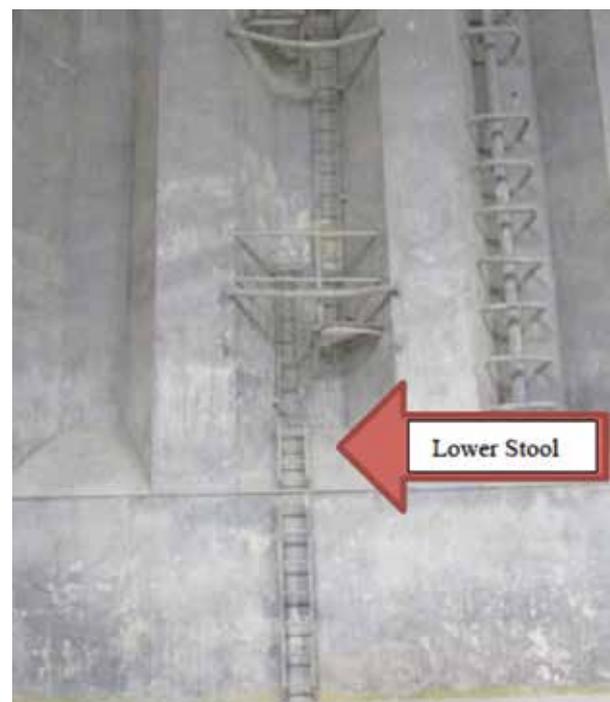
➔ Recently, a number of cases have come to light where persons have been seriously injured falling from cargo hold access ladders. It would appear that the victims involved in these accidents may have let go of the ladder prematurely, having mistaken the top of the 'lower stool' for the tank top at the bottom of the hold (see diagram below). In many large vessels, the distance between the lower stool and the tank top can be appreciable.

- Warning posters at the entrance to the holds may help increase awareness of this hazard.
- Safety notifications to external parties should include a brief to stevedores on the ladder markings for safe access.
- Ladders and stools should have safety indications for the users; for example, a clear marking about four metres above the tank top should indicate the situation. Additionally, another marking about 1.8 metres from the tank top should indicate the distance remaining.

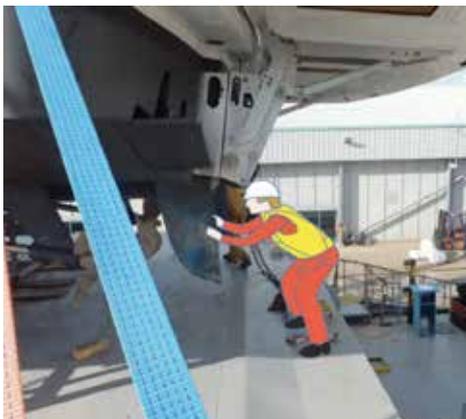
While loading the first motor yacht, the loadmaster asked the chief officer to ensure the yacht was aligned with its cradles. To do this, the chief officer went to the stern of the yacht, which was close to the unfenced edge of the hatch cover, and grabbed hold of its rudder. Once the yacht was lowered onto its cradle chocks the chief officer stepped back, but as he did so, he stumbled, lost his balance and fell 2.4 metres from the ship's cargo hatch cover to the main deck. He suffered multiple fractures to both of his ankles on impact, and was unable to return to work for 12 months.

Simulation of CO position just before fall

- Working on the hatch covers was a day to day activity on this vessel, which may have dulled the crew's risk perception of the fall hazard presented by working close to the hatch cover edges.
- Without edge protection, the risk of falling off the hatch covers was ever present on this vessel.
- Portable safety barriers and/or individual fall protection should always be used to protect against a known falling hazard.
- Many fall injuries occur at heights that are less than two metres.

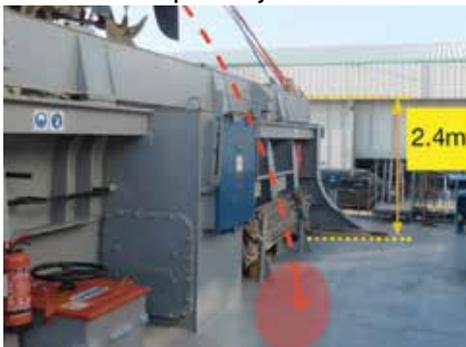
2.4m fall

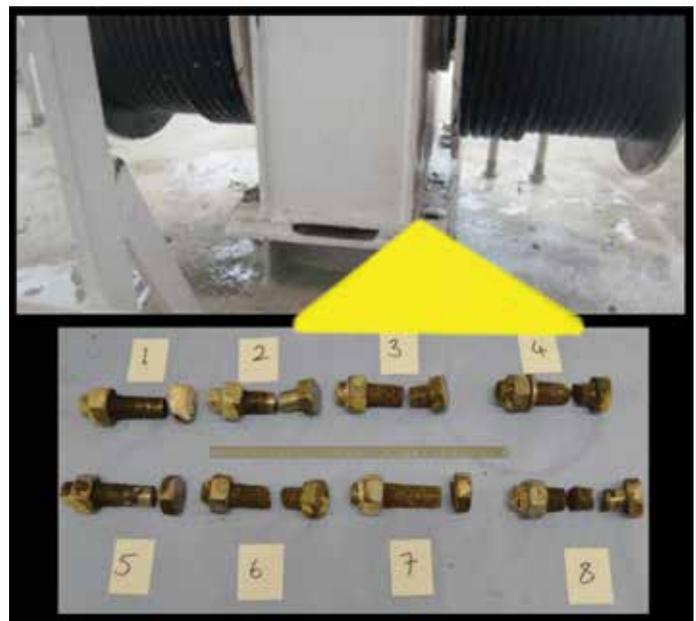
→ During a vessel inspection, a severed bolt was observed lying on deck in the vicinity of a lifeboat winch foundation plate. Further close inspection found that four other bolts out of a total of eight holding the foundation plate were also severed; these bolts were still retained within the foundation assembly by paint and corrosion.

This prompted an inspection of the winch foundation units on the three remaining lifeboats. On a second lifeboat, three out of eight bolts were detected as being severed while still held in place on the assembly by the paint coating. The remaining two lifeboat winch foundation assemblies were found to have no bolt failures.

The company investigation found, among other things, that the bolts had been in place for approximately eight years. They had failed as a consequence of corrosion. The chromium-manganese alloy from which these bolts were manufactured was not considered a suitable material for bolting in the marine environment.

- Although there was no mention of inspection or replacement routines of these bolts in the lifeboat manual supplied by the ship builder, a close-up inspection is considered prudent for such items.

- Replacing these bolts with appropriate new stock (eg grade 8.8 Hot Dip Galvanized bolts) every five years, just prior to the quinquennial testing, is a reasonable risk reduction action.

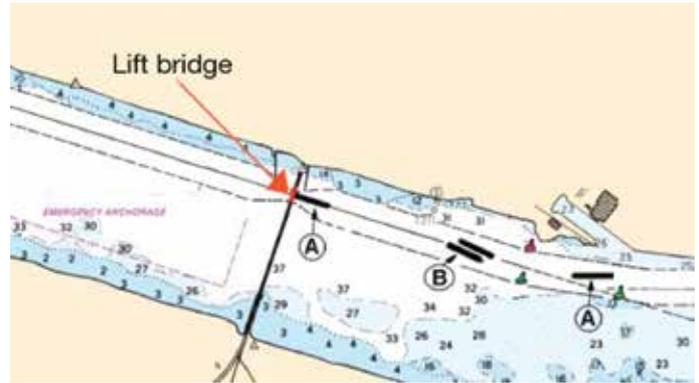
➔ In the early morning hours, in darkness and snow squalls, two ships were meeting in a narrow channel. Thirty minutes before the expected meeting, the officer piloting the up-bound vessel called the down-bound vessel to make meeting arrangements; he was to slow his vessel in order to meet below the lift bridge. The officer piloting the down bound vessel agreed, but the exact location of the meeting was not specified. Some time later, as the down-bound vessel passed through the opening of a lift bridge, the up-bound vessel was approaching a turn in the waterway (positions A in the diagram).

Time between positions A & B: 2.5 minutes

difficult to determine. Soon after, the officer piloting the up-bound vessel ordered hard starboard and requested full ahead on the main engine to help kick the bow to starboard. The two vessels nonetheless touched as they passed each other (position B) but avoided major structural damage.

- Good planning and clear communication is important, even if it is done 'on the fly'. In this case, the officer piloting the down-bound vessel agreed to meet 'below the bridge', but the exact location of the meeting was not specified. As it was, the vessels met at a location that was less than ideal given the relatively narrow channel width, the turn in the waterway, the prevailing currents, and the limited distance available to properly line up the lift bridge approach for the up-bound vessel.
- Never display lights that could introduce confusion for other vessels in respect of your navigation lights.
