Seaways

The International Journal of The Nautical Institute

Mariners' Alerting and Reporting Scheme

MARS Report No. 286 August 2016

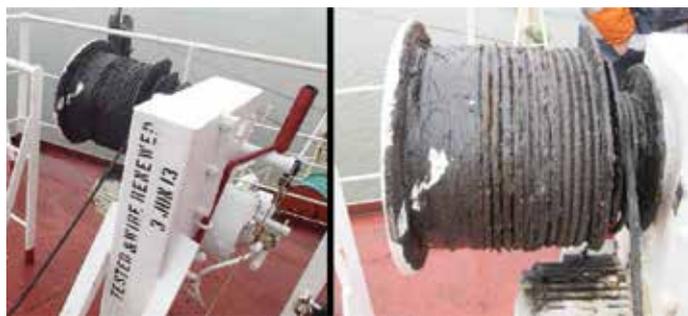
Heavily greased wire rope less than adequate

- The wire rope had been rigged incorrectly through the hook, introducing unnecessary stresses.
- The wire rope had a theoretical tensile strength that was approximately 25% less than that recommended by the davit manufacturer.
- Notwithstanding the heavy grease coating, the wire rope was severely corroded at the point of failure.
- The winch automatic shutdown limit switch was found to be defective.

Copious amounts of grease are not always a good sign

- Always rig boat lowering equipment with wire that meets manufacturer's specifications.
- Copious amounts of grease do not ensure that wire ropes are protected from corrosion, and may in fact hide corrosion deficiencies. Corrosion resistance can be increased through the use of galvanized wire in combination with speciality penetrating oils, which have the added benefit of reaching and protecting the wire rope core and keeping the wire clear for proper visual inspection.
- Ensure all limit switches are functional and wires are properly rigged according to manufacturer's specifications.

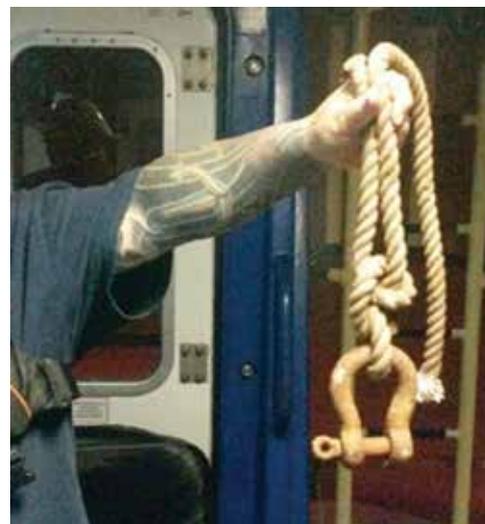
→ The vessel was approaching port under pilotage and the crew had to send a heaving line to a tug. Unknown to the tug crew, the heaving line had a large steel shackle attached to the end as a weight.

Luckily none of the tug crew was hit when the line was thrown some 10 metres down to the tug.

- Attaching weights to a heaving line in lieu of a proper monkey's fist or even a weight concealed within the monkey's fist is improper seamanship and could be very dangerous.

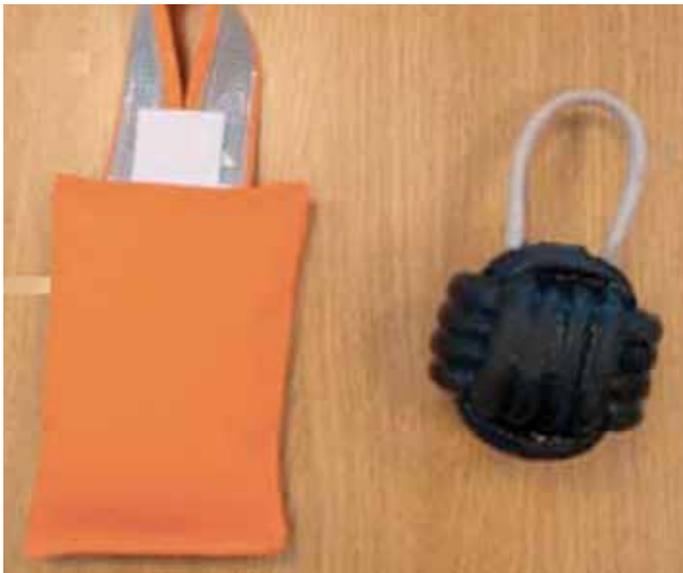
Proper monkey's fist or alternative pea-shingle pouch

■ **Editor's note:** General guidance exists to this effect, such as the United Kingdom's Maritime and Coastguard Agency publication Code of Safe Working Practices for Merchant Seafarers, 2015 edition. Section 26.3.5 of this publication states: "To prevent personal injury to those receiving heaving lines, the monkey's fist should be made with rope only and must not contain added weighting material. Safe alternatives include a small high-visibility soft pouch, filled with fast-draining pea shingle or similar, with a weight of not more than 0.5 kg. Under no circumstances is a line to be weighted by items such as shackles, bolts or nuts, or twist locks."
