# Seaways

# Mariners' Alerting and Reporting Scheme

MARS Report No. 293 March 2017

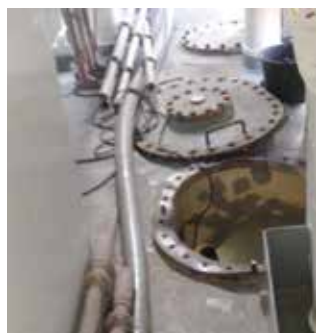
### Open manhole hazard

➔ During vessel loading, a shoreside foreman was walking on deck where other maintenance activities were taking place. As he made his way on deck the foreman inadvertently stepped into an open manhole. He was able to catch himself and prevent a free fall of 5 metres into the tank. The victim suffered a laceration on his shin, which required three stitches, and some bruising on his forearm.

- Once opened, a manhole should be cordoned off to provide protection and warning concerning the hazard.
- When a variety of activities are going on simultaneously that involve different work teams the risks are increased. Coordination and toolbox meetings before starting the work can help mitigate these risks.

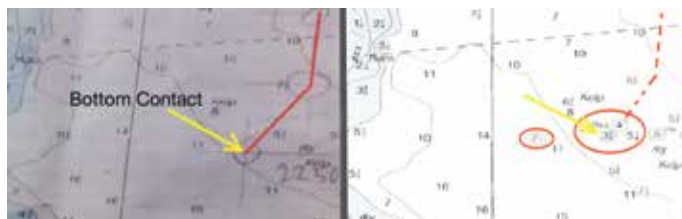
Chart in use

### Unexpected bottom contact

➔ An ice-strengthened oil exploration support vessel left port under the con of a pilot; the Master and OOW were also on the bridge. About five minutes after having left the berth, and while proceeding at about 3.5 knots, a loud noise was heard and a slight shudder was felt throughout the ship. At the time it was thought that the noise and shudder were caused by the anchor being secured in the anchor pocket. A few minutes later the pilot disembarked and the vessel continued on its voyage.

Over the next few hours it was discovered that the number 4 port ballast tank was taking water at a rate of about 8m<sup>3</sup>/hr. Even though the vessel's ballast pumps could discharge at 100m<sup>3</sup>/hr, the Master turned the vessel around and they returned to berth for further inspections.

Once at berth, divers confirmed a fracture on the bottom plate of number 4 port ballast tank. New depth surveys of the area of presumed bottom contact were conducted by the National Hydrographic Service. Several previously uncharted shallow areas and rocks were discovered and a new chart was subsequently published.

- Some isolated ports still rely on charts that are based on relatively old surveys. In this case, the chart used had been issued by the National Hydrographic Service and was based on a 1935 survey.
- Unexpected noises and a shudder were an indicator that something out of the ordinary had happened. Because the ballast tanks were equipped with tank level gauges the crew quickly noticed that one of the ballast tanks was taking water. If you experience unexpected noises, always assume bottom contact and sound all tanks.

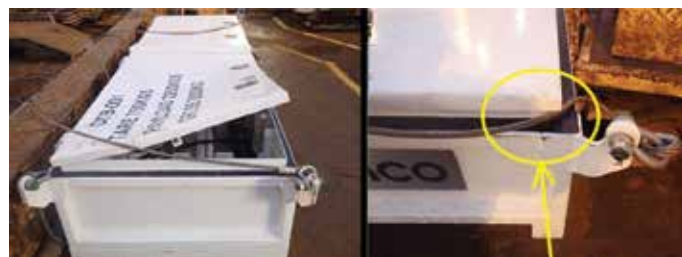
➔ A supply vessel was working alongside an offshore installation carrying out cargo operations which included the discharge of a small cargo basket. After unhooking the previous back-loaded cargo unit the deck crew 'walked the crane' approximately 15 metres and hooked on a cargo basket. They then left the area and the crane began to take the strain. As the slack was being taken up the lifting bridle caught under the lid of the basket. The crane driver noticed the lifting bridle snagging and lowered the load. Unfortunately, both deck crew had walked away from the basket in different directions and neither was observing the lift. Neither was therefore aware that the lifting bridle had snagged, nor could they see each other to highlight the problem.

After a short time both crew members made their way back to the basket and cleared the lifting bridles. They then stood clear in a safe haven nearby while the crane took up the slack, but once again the lifting bridle caught on the lid, this time buckling the lid and exposing the cargo inside.

Lifting bridle snagging the lid

- Good communication between deck crew and crane operator is essential. Repetitive work cycles can leave workers complacent. Complacency eventually leads to accidents.
- The operation and difficulties encountered were witnessed by at least three individual parties (the deck crew, the vessel’s bridge team and the installation), but no-one stopped the job.
- ‘Walking the crane’ (or more precisely the hook) is not best practice. Allow the hook to be repositioned directly over the load, have it lowered, hooked on and then lifted.

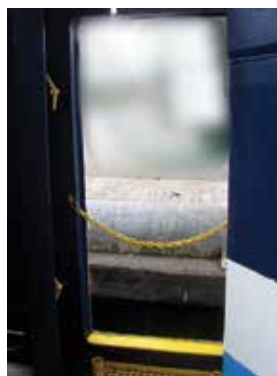
➔ A vessel was in the process of berthing. The engines and thrusters were still running, and the aft mooring station personnel had just confirmed to the bridge team that the vessel was all fast aft. Before coming to berth, the side (pilot) door had been opened to facilitate monitoring of the rescue boat, which had been launched and recovered for survey purposes. The door was still open during the berthing manoeuvre but a safety chain was in place to indicate the hazard.

The open door was about at the same height as the quayside. A classification

Pilot door and chain

society surveyor, who was on the wharf waiting to board the vessel, removed the chain himself and hopped on board through the door.

- Side/pilot doors should be kept closed when not in use.
- Open side doors that are soon to be used should be attended by ship’s crew trained in their duties. They should be strongly advised to let no one attempt a boarding or disembarkation without a proper gangway in place. A sign should be installed on the safety chain to reinforce the interdiction.
- Even experienced mariners and surveyors can be tempted to skirt safety rules for the sake of expediency. Never be intimidated by the rank or title of a visitor and stick to your vessel’s procedures.

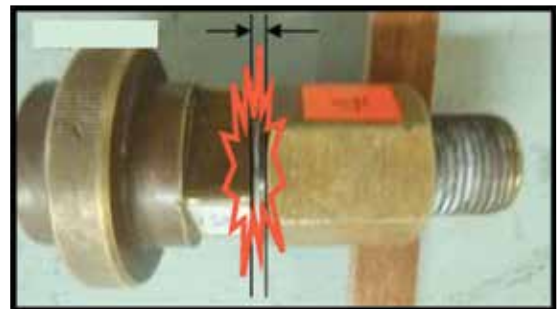
➔ A ship’s officer was tasked to recharge a compressed air bottle from the lifeboat. During charging, the union/adaptor connection between the compressor and the air bottle disconnected and blew away. Pressure in the bottle at the time was about 100 bar; the maximum designed pressure of the air bottle is 200 bar. Luckily, no-one was injured.

The company investigation found that the specification of the union/adaptor used on board was a different specification from the original. The male part of the union was a taper thread while the female part was a straight type. A proper fit would have matched fittings; taper with taper or straight with straight.

Taper thread

Straight thread

- Air compressors create high pressures so accidents involving them can have serious consequences. Training and familiarity with the equipment is needed before use.
- Always inspect compressor fittings carefully before connecting; sometimes mismatched parts can be mistakenly used.

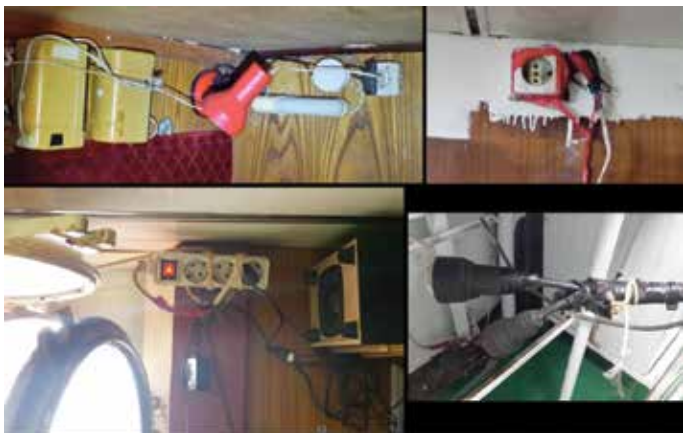
The fire was caused by a household type fan heater that was used to dry the working gear of the crew in the cabin. The investigation also documented many areas in the vessel with 'home-made' and octopus connections as well as other electrical anomalies.

- Improved and home-made solutions involving electrical equipment are accidents waiting to happen. The Master's inspections, presumably done at least weekly, should have rooted out this bad practice before it caused a fire and a fatality.
- Carbon monoxide poisoning can kill very quickly, as we learn from this accident. A quick rescue was still not enough to save the victim's life.

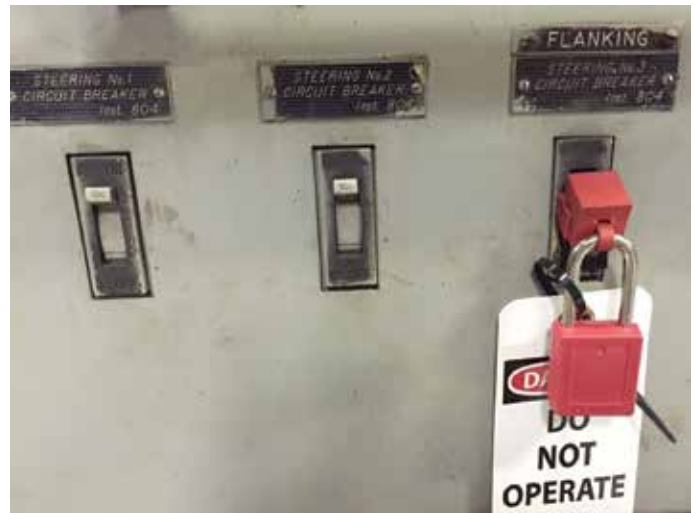
➔ A tugboat was in port for repairs. The company's port engineer boarded the vessel to check on the ongoing repairs and in particular the status of the steering equipment maintenance. On his way aft he passed the main breaker panel and noticed the steering pump breakers on the main electrical panel were still energised and there was no lock-out/tag-out (LOTO) in place. As he continued to the steering compartment he looked to see if the rudder motor controllers were in the off position. The controllers were in the off position, but with only one LOTO tag affixed to one controller.

When questioned about the inadequate LOTO tags, the crew member in charge stated he was distracted and overwhelmed by the shore gang's presence on board and the number of jobs to be completed.

The company investigation also found that although there was a general procedure for LOTO, there was no specific checklist for each piece of machinery.

- There are no excuses for inadequate LOTO practices. This should be the first thing you do before any job that involves machinery with stored or potential energy release. Go through the proper LOTO procedure no matter what the apparent time constraints imposed.
- Good communication and coordination are needed between shore gangs and vessel crew to avoid unnecessary mix-ups and missteps in procedures.
- In your LOTO procedure, each piece of machinery should have a list of the breakers that must be opened and locked-out prior to work being permitted on that machinery.
- A 'permit to work' programme is a helpful tool to manage work processes and ensure compliance, especially when various parties such as shore gangs are working aboard.
