# Seaways

# Mariners' Alerting and Reporting Scheme

MARS Report No. 298 August 2017

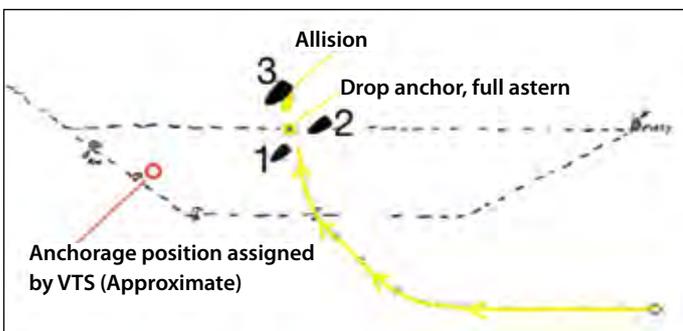
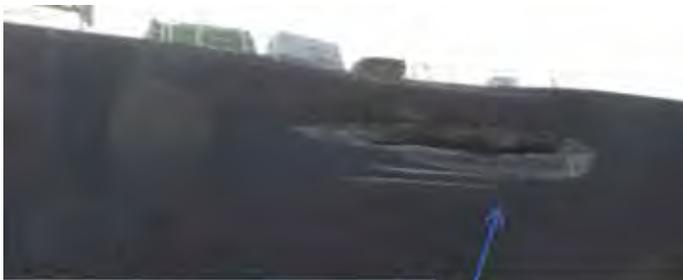
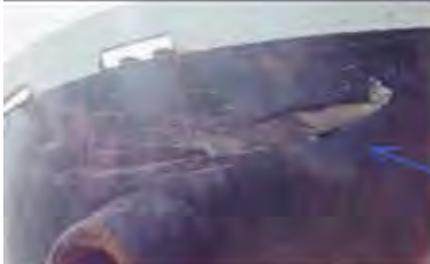
Damage to vessels

was also dropped to lessen the impact. Shortly afterwards the dry bulk carrier, still making 2.5 knots, made contact with anchored vessel three. Substantial damage was sustained by both vessels.

The official investigation revealed that essential information on the pilot's intended passage and anchoring operations was not discussed during the Master-pilot exchange. The alternate anchorage position chosen by the pilot was not challenged by the bridge team. The investigation also found that the plotted positions of the vessel varied sharply from true positions as shown by the AIS and VTS recorded track. This is indicative of inadequate monitoring and inaccurate situational awareness.

- Manoeuvring large vessels into crowded anchorages takes planning, skill and good teamwork.
- Always know the plan. If you observe a deviation, ask questions and/or make a challenge.
- Even with a pilot at the con, always accurately monitor your vessel's position and keep the pilot informed of the vessel's progress.

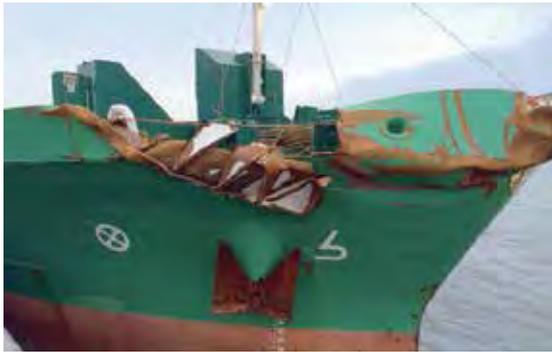
ballast and had hardly any speed, manoeuvring was hampered and the vessel's movement was greatly affected by the strong wind and current, now acting fully on the vessel's starboard side. The tanker was driven into the bow of the general cargo vessel - which was still anchored, but dragging - causing major damage to both vessels.

Damage to the general cargo vessel

- Vessels proceeding at low speeds, especially those in ballast condition, are greatly affected by wind and current.
- By stemming forces acting on your vessel you can maintain better control at low speeds.

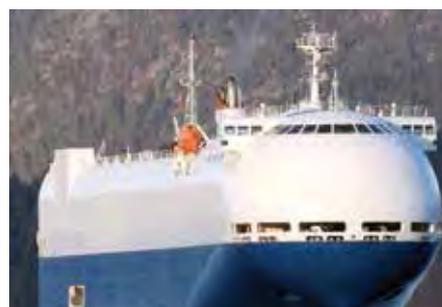
Car carrier's unconventional wheelhouse

- The car carrier pilot's view from the window he was using was 33° off the vessel's centreline axis, which contributed to the relative motion illusion. It deceived him into thinking that his view was the same as the vessel's direction of travel.

- The inward slope of the bridge window removed all objects from the car carrier pilot's peripheral vision. There were no forward visual clues such as a bow tip, and the illusion would have been compelling.

- When in pilotage waters do your own navigating to validate the pilot's actions and to keep your situational awareness at its peak.
- Keep the pilot apprised of any deviations from the planned track and the vessel's actual track.
- If your vessel has special ergonomic characteristics or particular manoeuvring considerations, make sure the pilot is well informed of these points and that they are taking them into consideration while under pilotage.

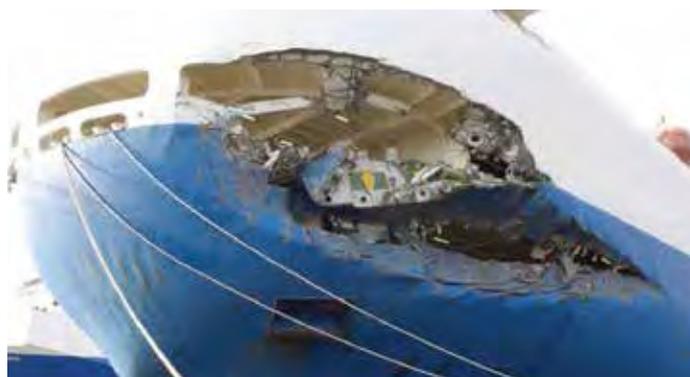
Car carrier damage

- The collision stemmed from the car carrier being set to the northern side of the channel by the wind and the tidal stream, followed by the distortion of its pilot's spatial awareness due to a 'relative motion illusion'.

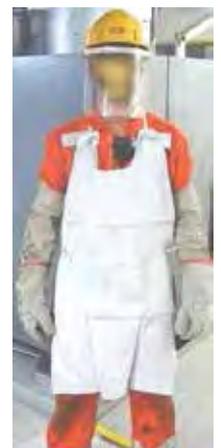
→ Two engine room crew members were tasked with loading the incinerator. Although the incinerator was not in operation at the time, it had recently been used and was still hot. One crew member opened the incinerator door and deposited some articles that contained oily waste into the incinerator. The oily waste ignited in a flash fire and the two crew members received severe burns to their faces. The victims were sent ashore for medical treatment.

- Before opening the furnace door for either cleaning or putting in garbage and/or oily waste, it must be confirmed whether unburnt sludge and/or embers remain, using the sight glass and furnace temperature indicator. Never open the door if it is still hot or smouldering.
- Before opening the furnace door always wear proper PPE, as shown right. Anticipate the possibility of a flash fire. Proper PPE includes full face shield, long sleeves and heat resistant gloves.
