Seaways

The International Journal of The Nautical Institute

Mariners' Alerting and Reporting Scheme

MARS Report No. 299 September 2017

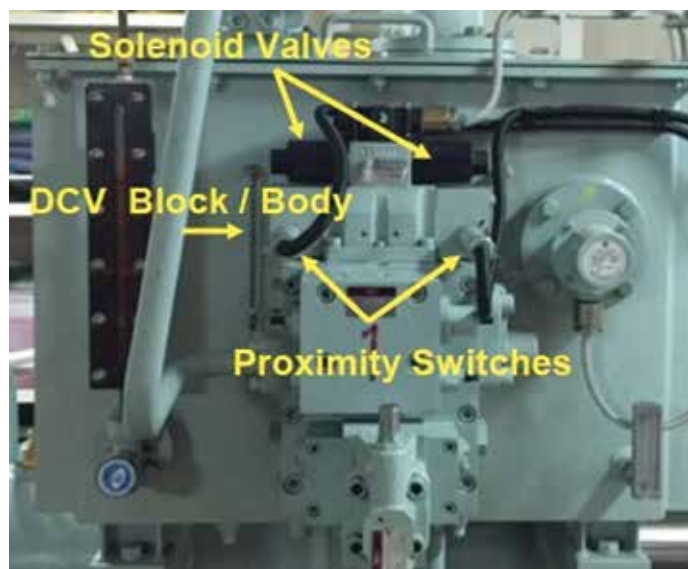
➔ Repetitive alarms occurred when crew performed steering tests to move the rudder through its range of motion. The alarms indicated a 'hydraulic lock' event, even though the steering gear had moved the rudder adequately during the test. On each occasion the crew simply acknowledged the alarm, without making any further investigation to identify the cause.

The hydraulic system that moves the steering gear's rams involves a directional control valve (DCV), which is a hydraulic shuttle valve. A set of solenoid valves receives an electrical signal from the bridge helm or autopilot, which causes a flow of oil to certain sections of the shuttle valve. The DCV shifts and initiates flow to the system's hydraulic rams dependent on the command. If the shuttle valve does not shift, or is not sensed as having shifted (via magnetic proximity switches) after a period of time, it activates an alarm on the bridge console.

In this case, the proximity switches were found to be faulty and needed replacement. Although the rudder moved as expected in the tests, the lack of properly functioning proximity switches combined with a complacent attitude had 'trained' the crew to ignore the alarm.

- The management of nuisance alarms should be addressed in the company's safety management system.
- If an alarm has become a nuisance, find out why and correct the situation.
- Never pin or otherwise secure an alarm acknowledgement button or switch in order to silence the alarm.
- Nuisance alarms can, over time, desensitise an operator to real problems that may be indicated by an alarm.

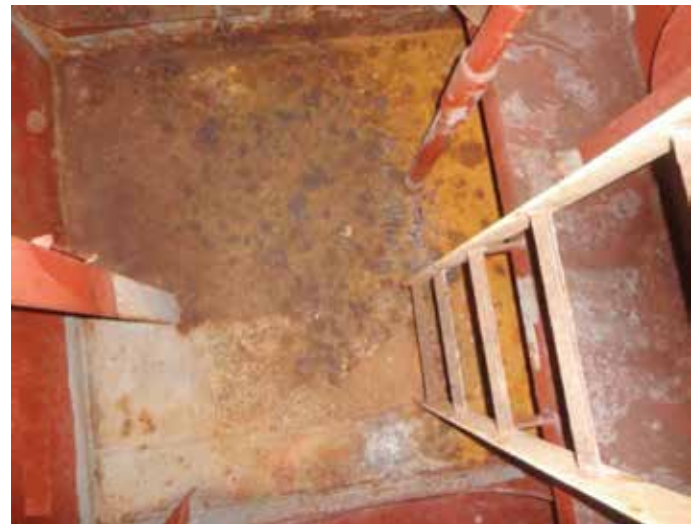
View of part of the hold access ladder

- A contributing factor to the accident was the perceived absence of threat within the enclosed space that contained the hold ladder.
- Despite posted safety signs warning crew to confirm oxygen content of the space before entering, this procedure was not followed.

- Some enclosed spaces, such as a hold access ladder, may seem less risky to mariners due to their familiarity. Never fall into this trap. Treat all enclosed spaces equally by testing for oxygen content before entering and deploying the full enclosed space procedure each time.
- Identify all enclosed spaces on board your vessel and mark them as such.

- Warning signage is a preliminary barrier to protect against risks in enclosed spaces, but it is not sufficient on its own. Correct entry into enclosed spaces must be an integral part of the culture in the company and on the vessel.
- Never rush into a confined space to rescue a crew member who has collapsed. Call for help and put your enclosed space rescue routine into effect.
