# Seaways

# Mariners' Alerting and Reporting Scheme

MARS Report No. 289 November 2016

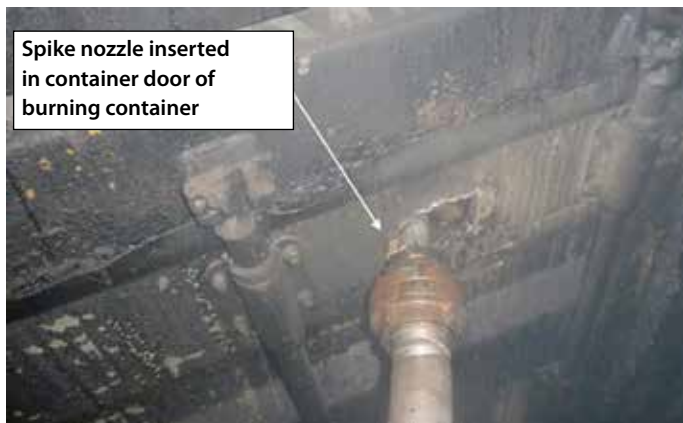
Some time later, a team entered the fire area with the ship's special 'container firefighting equipment'; a cordless power drill, a hole saw bit and a spike nozzle. However, the power drill was not able to penetrate the container door. It was decided to close the hold, maintain the cooling, and allow the crew some rest and time to consider alternative

Spike nozzle inserted in container door of burning container

approaches. Later, another attempt at placing the spike nozzle in the burning container was successful, this time using an angle grinder to cut the container open. A spike nozzle was inserted and water injected into the container; soon after, the fire was considered under control.

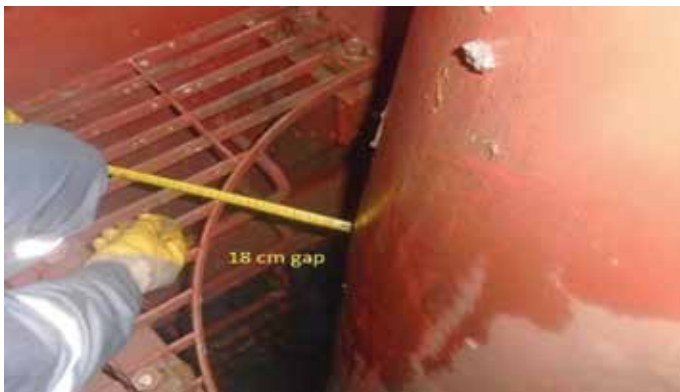
Later, during discharge of the cargo, a team of custom officers attended the vessel. During their detailed search drugs were found hidden in the rudder trunk. The investigation revealed that there was a lack of proper guards around the rudder stock (image below), allowing potential unauthorised access for drug trafficking purposes.

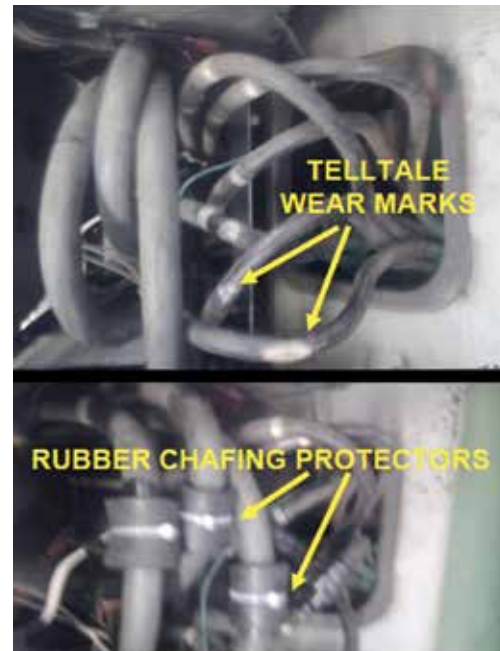
### Before

It was found that one of the primary leads exiting the generator housing had chafed against its steel enclosure, causing it to ground out. Investigators determined that other vessels operated by the same company had similar generators and wiring arrangements. Inspection of those generators showed similar signs of chafing and abrasion, but the wiring had not yet reached the point of failure.

- Vibration is a well known causal factor in fuel oil spray fires. While this situation is different from a failed fuel line, the unsafe condition leading to the failure is similar.
- Always consider what could happen as a result of vibration. Inspect at-risk areas such as piping systems connected to the engine, engine mounts, pipe clamps, wire bundles, brackets, and areas where connected components pass through decks or overheads.

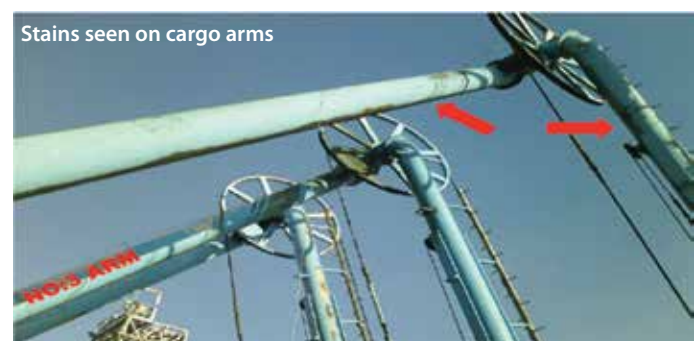
The cause of this incident was the leaking vacuum relief valve located at the top of one of the loading arms, an area not easily visible. Apparently, this deficiency had been known to exist by shore authorities. Some stains were also seen on one of the other shore arms, though no actual leakage was observed there during cargo operations.

- Since the vessel crew do not have specific knowledge about shore cargo arms, any potential risks should be discussed and highlighted to crew by the terminal during the pre-discharge safety meeting.
- For oil cargo operations, when any unusual event is encountered or suspected all operations should be stopped and the event fully investigated.
- Any apparent deficiencies of shore equipment seen by ship's crew should immediately be reported to the Master and port authorities.
