Seaways

The International Journal of The Nautical Institute

Mariners' Alerting and Reporting Scheme

MARS Report No. 251 September 2013

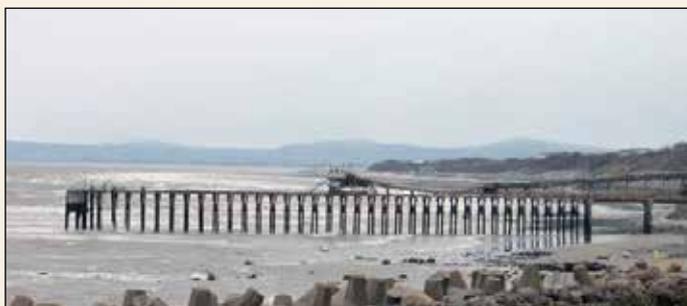
→ A small coastal cargo vessel had been loading limestone at an exposed, tide-constrained berth when the weather, as predicted, continued to worsen. The master, after listening to the weather predictions, decided to finish loading and then put to sea. However, strong winds and large waves overwhelmed the vessel while it was manoeuvring away from the jetty, causing it to be driven onto the shore. The vessel was later declared a constructive total loss.

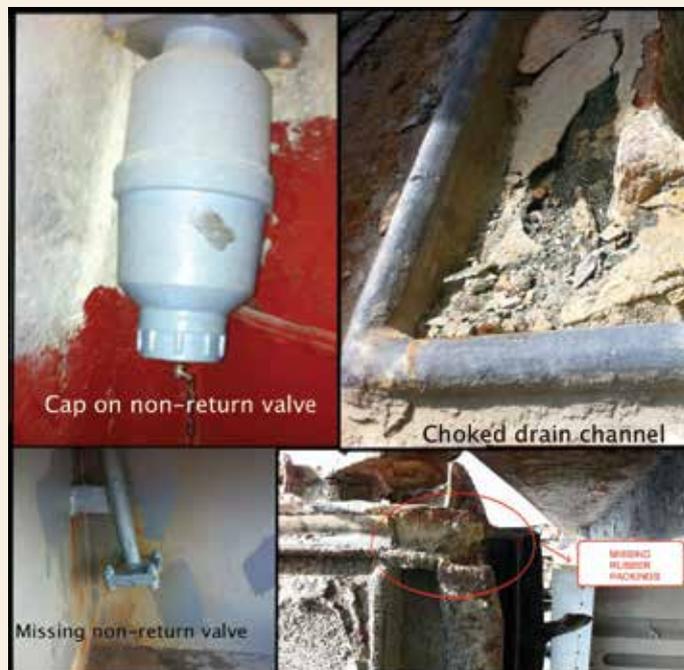
does enter the hatch cover, by design it goes into the drain channel, through a non-return valve, and then passes on to the deck. The non-return valve ensures water can only go from the drain channel to the deck and not vice versa.

Unfortunately, inspections have revealed missing, blocked or otherwise plugged non-return valves and drain channels. Some non-return valves have even been found capped. These conditions mean that water which enters the hatch cover is not able to pass out from the hatch cover drain channel and instead goes into the hold, resulting in cargo damage.

Inspections have also revealed hatch cover rubber packing that is missing or damaged. Where repairs have been effected, they sometimes appear to have been made too localised to the damage (six to twelve inches, whereas manufacturer's instructions normally require a minimum of twenty four inches to be changed.) The ends of the repair packing should be cut at a 45 degree angle, not vertically, and the packing should be hammered from the centre towards the sides.

Another deficiency noticed during inspections is with the rubber washers of cleats. Often, these washers are either too hard (due to age) or covered by thick layer of paint which makes the rubber washer ineffective.

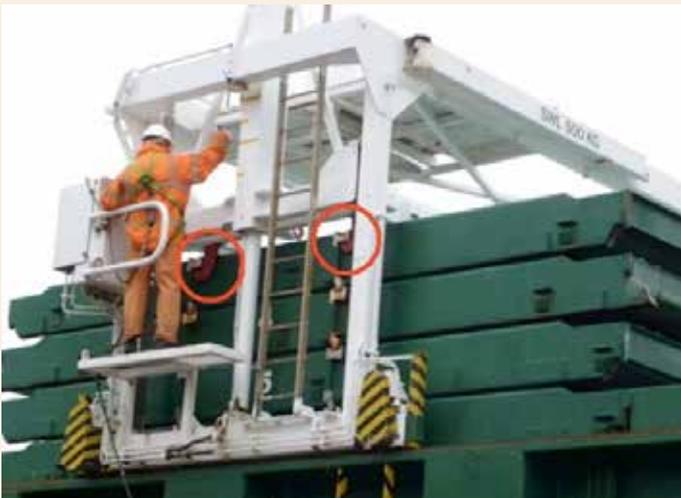
The hatch crane and hatch arrangement are similar to those in many small ocean going and inland vessels. The hatch crane rides on both sides of the hold over rails which are fitted to the hatchway coaming. The crane consists of two vertical uprights and a yoke, placed athwartships [across the width of the vessel] and fitted with hooks from which the hatches are hung during hatch movement. The hatches are fitted with attachment points, referred to as 'pockets'. There are markings on both the hatches and the hatch crane to indicate the correct position of a hooked-up hatch relative to the hooks of the hatch crane. The person who operates the crane stands on the hatch crane, either on one side or on top, and rides along with the hatch crane while the hatch is moved.

The hatch crane with hatch in hooked position

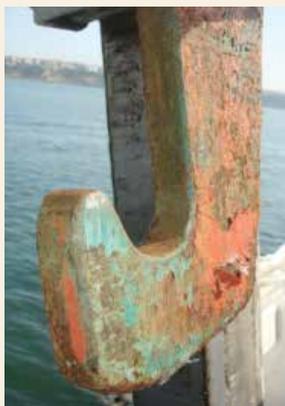
Because the hatch was being transported in a high position, not only was its centre of gravity higher than need be, but also there was little chance of it coming to rest on the hatchway coaming when it fell. The investigation also determined that the hooks of the hatch crane yoke on the starboard side did not connect to the hatch attachment points but to the rounded (outer) side of the attachment points. Contrary to the vessel's procedures, this was not checked by a second person at the time of the manoeuvre.

Hooks used with blunt end

- 1 Use claws on the hatch crane which grip the rails so that the crane cannot topple or shift off the rails.
- 2 Use sharp ended hooks and pockets, so that the hook cannot lift the hatch if it is not properly connected.

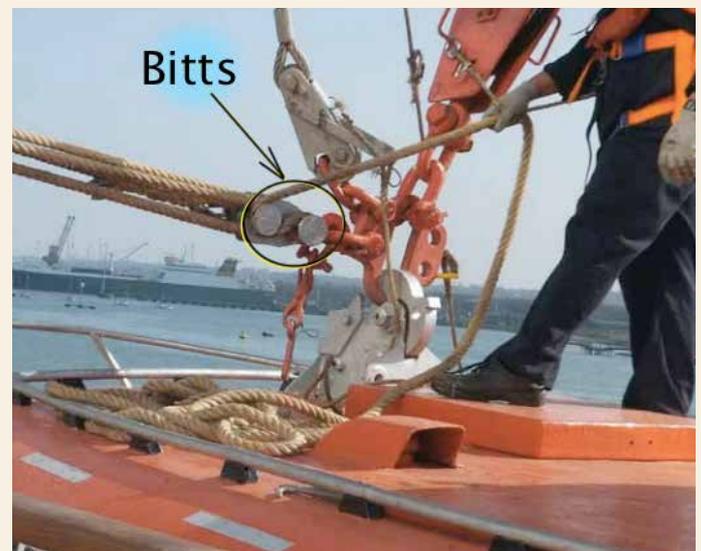
→ As part of a drill, the outboard lifeboats and tenders of a passenger ship were lowered and held alongside deck nine by their tricing pennants. The lifeboat's bowing tackles were rigged, tensioned from

the coach roof and secured to bitts welded to the bowsing tackle blocks fitted to the lifeboat lifting plates.

On the order to release the tricing pennants, the forward crewman was unable to remove the tricing pennant hook release lever pin while at the same time holding the bowsing tackle on the bitts. The overseeing officer went to assist. As the officer removed the pin and operated the release lever, the crew member stepped to one side, which caused the bowsing rope that he was holding to come free from the bitts. Without tension on the bowsing tackle, the lifeboat swung violently away from the ship's side and heeled to port. The officer and crew member, who were not wearing any form of personal restraint, slipped from the smooth coach roof and fell 22 metres into the water below. They were quickly recovered by other members of the crew. Luckily, the two men sustained only minor injuries.

While other factors contributed to this accident, had the men been wearing proper fall restraint equipment they wouldn't have taken a 22 metre plunge into the harbour waters. When working where risk of falling is present, fall restraint PPE is your last line of defence.

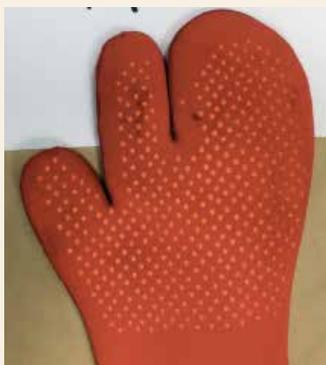
After the general alarm was sounded, the crew assembled on the bridge and donned immersion suits collected from two decks below. These were a mix of different types - some of the suits were required to be donned with lifejackets, others were not. As the vessel's freeboard reduced, the master realised that the vessel was sinking and ordered the crew to prepare to launch the liferafts. At about the same time, the second officer collected the two search and rescue transponders (SART). However, he had difficulty activating them because of the design of the gloves integral to his immersion suit (see picture below), and eventually had to use his teeth to operate them.

- Having several different types of immersion suit and lifejackets on board is potentially confusing and increases the risk of the equipment either being donned incorrectly or not quickly enough. It is commonsense that all of the immersion suits provided on board a vessel should be of the same type; i.e. either they all have in-built buoyancy, or they all need to be worn with a compatible lifejacket, but not a mix of the two designs. Even in large fleets that carry many types of suits and lifejackets, this can usually be arranged through good planning.
