Seaways

MARS Report No. 305 March 2018

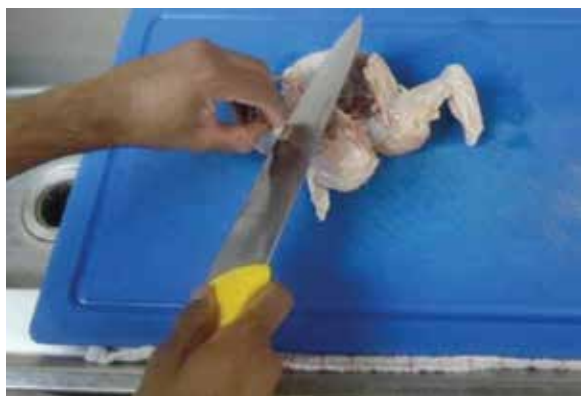
→ On a vessel underway, the cook was in the galley preparing meals. One of his tasks was to skin and cut poultry. While attending to this job he accidentally cut a finger on his left hand. The investigation revealed that although the chicken was tested for appropriate tenderness before cutting and the knife used was properly sharpened and the correct size for the task, the cook was not wearing a protective 'cut glove' on his left hand.

Using a protective 'cut glove' on the hand that holds the item to be cut is not always the first choice for cooks, but it should be. Just as hard hats and steel-toed boots are now the norm on deck and in the engine room, in the kitchen appropriate PPE should become part of the culture.

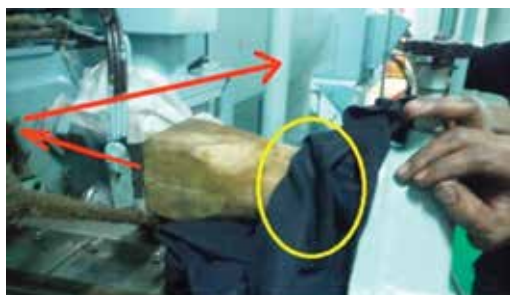
→ Two engine room crew were about to undertake a pressure test of an auxiliary engine air cooler. To this end, the sea water outlet pipe of the cooler was sealed using a large wooden plug and a piece of cloth acting as an improvised gasket. The air cooler was partially filled with water and then air pressure of about 4 bar was applied to the cooler from the sea water inlet side. Suddenly, the wooden plug shot out like a bullet with tremendous force and speed.

Red arrows show trajectory of plug

After bouncing off a casing the plug hit one crew member on his helmet, then ricocheted and hit the other crew on his forehead. While the first crew was unhurt, the second was injured, suffering swelling of the forehead with severe pain. Fortunately, the injury was not serious.

- Wooden plugs or other improvised methods that do not ensure positive and secure closing should never be used for pressure testing.
- Other than on pressure vessels like boiler shells or compressed air bottles, pressure tests should be carried out by hydrostatic means, by filling the appliance with water and creating a head of pressure appropriate for the required test.

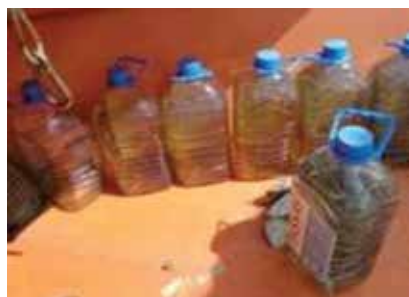
→ The crew noticed that there was no extra diesel fuel on the fast rescue craft (FRC), so they searched for containers to store the fuel. Some plastic bottles were found and used to store the diesel in the FRC.

Later, during a vessel inspection, these containers were observed and it was pointed out that storing diesel in inappropriate containers is a safety deficiency. These containers were old water bottles, which could cause confusion and possibly induce someone to mistakenly drink from one of the bottles.

- Never use improvised containers for fuel or chemical storage, especially old drinking water bottles. This has the double disadvantage of being a risk to the environment and dangerous for anyone who might drink the contents.
- Always insist that ready-use fuel or chemicals are stored in appropriate containers.
- If ready-use containers for fuel or chemicals are bought in bulk, ensure they are labelled correctly, including safety data sheet references and full product name.

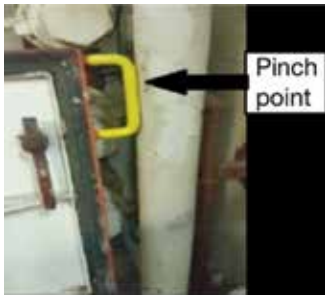
➔ A crewman needed to lift an escape hatch cover from the machinery spaces. He grabbed one of the yellow handles and raised the hatch, but he was unaware of a pinch point that existed between the handle and a nearby pipe.

As he brought the hatch to the upright position his finger was caught in the pinch point causing a serious injury to his finger.

- Risk assessments should be done on your vessel and pinch points should be targeted. If possible, these hazards should be eliminated.
- If it is physically impossible to eliminate certain pinch points, they must be clearly indicated and should form part of the vessel's familiarisation checklist.

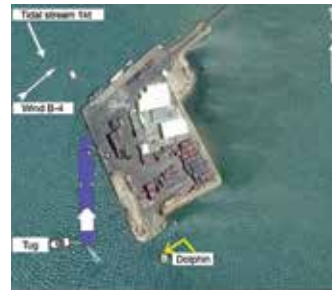
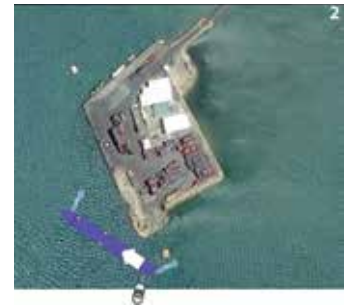
The Master was initially concerned about the tug's ability to assist the ship effectively in the planned manoeuvre, and requested the pilot to direct the tug to pull on the port beam with full power. The tug's performance satisfied the Master, so the stern mooring lines were let go. With the stern lines away and the tug continuing to pull at full power, ahead propulsion was ordered and starboard helm applied on the container ship. The resulting actions caused the vessel to pivot on the remaining forward backsprings, thereby enhancing the stern's movement away from the quay (diagram 1).

Within a few minutes, the container vessel's stern was about 25 metres from the quay; the forward backsprings were then let go. The engine was then initially put dead slow astern with the bow thruster full to port, and then hard to starboard helm and dead slow ahead, with the bow thruster remaining full to port. Shortly afterwards the helm was ordered amidships and then hard to port, but the vessel was by now moving astern with its stern coming dangerously close to the

mooring dolphin (diagram 2). Half ahead was ordered and the bow thruster half to port, and then full ahead, hard to starboard helm and bow thruster full to port in order to avoid hitting the dolphin. Soon, the ship was moving ahead at more than 5 knots. The tug, which was now astern of the vessel, was unable to gain a safe position because of the unexpected (to the tug crew) and rapid forward motion of the container ship. It quickly girded and capsized.

- When in doubt, reconsider your plan. In this case, the tug in service was approximately one-quarter as powerful as the tug normally used and the Master had some doubts about its efficacy before undertaking the manoeuvre.
- Always keep assisting tugs apprised of your vessel's movements, preferably before the movement begins.
- For tug crews, ensure your vessel is seaworthy and the crew properly trained and equipped.

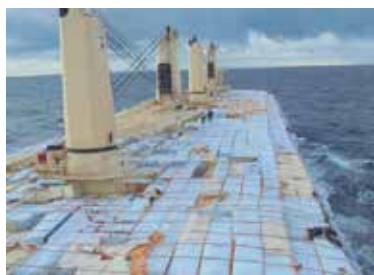
Following the supercargo's instruction, the ship's crew secured the deck cargo by means of top-over lashings using chains and turnbuckles. Wooden ladders were constructed at the fore and aft ends of the deck cargo stack to allow access between the accommodation and the forecastle.

Vessel loaded and underway

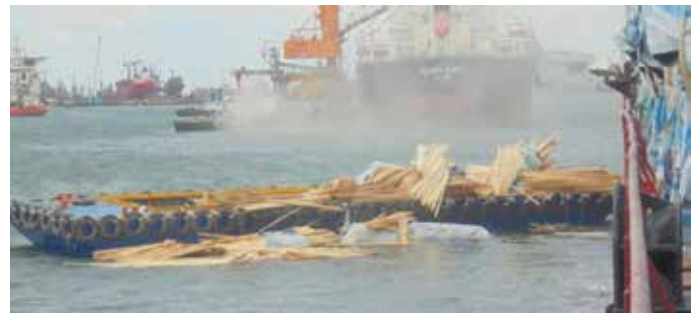
Two barges were alongside on the starboard side and one barge was positioned on the port side. At one point during the discharge about 20 packages of timber, each about 2 tonnes, tumbled overboard from the port side. Cargo operations were stopped. It was then realised that the bosun had been standing on top of the stacks that had gone overboard.

Scene of the accident

- With the deck cargo lashings removed, the cargo packages stowed on deck had insufficient stability.
- The use of uprights would have helped prevent a deck cargo stack from collapsing once the securing lashings had been removed.

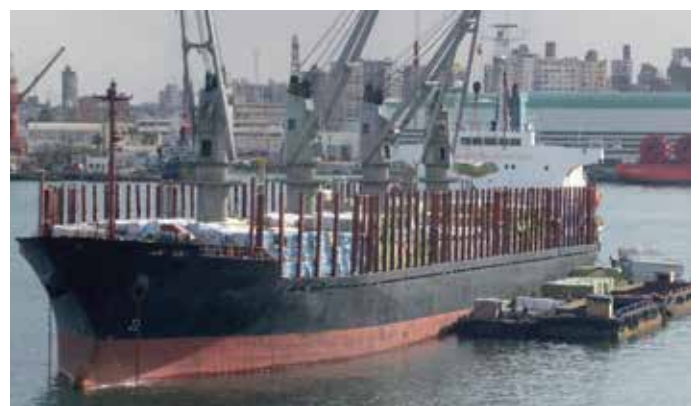
- The provisions contained in the IMO Code of Safe Practice for Ships Carrying Timber Deck Cargoes (TDC Code 2011) is unequivocal in its recommendation that 'uprights', as shown below, at least as high as the stow, should be used to stabilise stowed round wood, loose sawn wood and sawn wood packages with limited racking strength.
