Inadvertent Release of a Freefall Lifeboat

The Australian Transport Safety Bureau (ATSB) has recently published a preliminary report regarding the inadvertent launch of a freefall lifeboat from a geared handymax bulk carrier while on a ballast passage in the Indian Ocean.

This Safety Alert is based on a preliminary report into the [Unintentional release of the freefall lifeboat from the bulk carrier Aquarosa](#) published by the Australian Transport Safety Bureau. It is important to note that the ATSB's final report may contain findings and recommendations which differ from those in the preliminary report and in this Safety Alert.

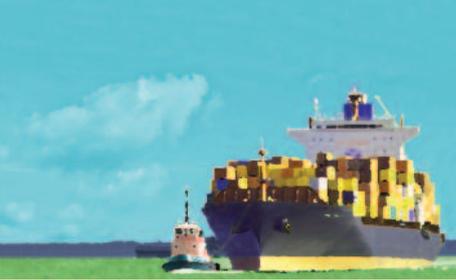
The release mechanism was fitted with a pin which passed through the hook and its adjacent cheek plates to prevent it from tripping. It was necessary to remove the pin in order to
