Loss Prevention Bulletin

The use of ECDIS Alarms

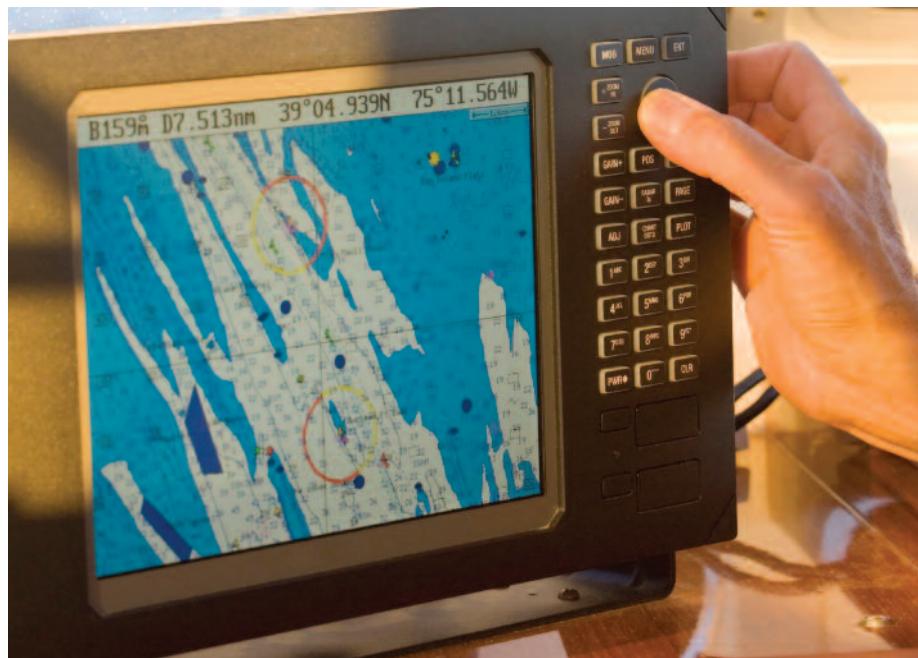
A 19,000 GT self-discharging bulk carrier was on a loaded passage through confined waters when the vessel grounded and sustained a 3 metre fracture in a ballast tank. The bridge watchkeeping officer had made a number of alterations of course to avoid a sailing vessel and another small craft. These collision avoidance manoeuvres forced the vessel away from

the planned track and into shallow water where the vessel grounded at 12 knots.

The vessel had a maximum draft of 10.6m and may also have been affected by squat. It was subsequently found that the safety contour had been set to 10m which, even allowing for the rise of tide above chart datum, was clearly inadequate.

The alarm was triggered before the safety contour was crossed, but the only warning was a visual alert on the ECDIS screen. This was not noticed by the watch-keeping officer as he was engaged in collision avoidance and was not monitoring the vessel's position on the ENC. Although an audible alarm should have sounded in addition to the visual alert, the audible alarm feed had been disconnected.

The Master and deck officers had completed a generic ECDIS training course based on IMO Model course 1.27. However, the official investigation report concluded that their knowledge on the use and functionality of the ECDIS safety features was insufficient as they had not undergone any type-specific training. In particular, they failed to recognise that the safety contour setting was inappropriate for the voyage and were unaware that an audible warning should have sounded when the safety contour alarm was activated.
