Mariners' Alerting and Reporting Scheme

MARS Report No. 319 May 2019

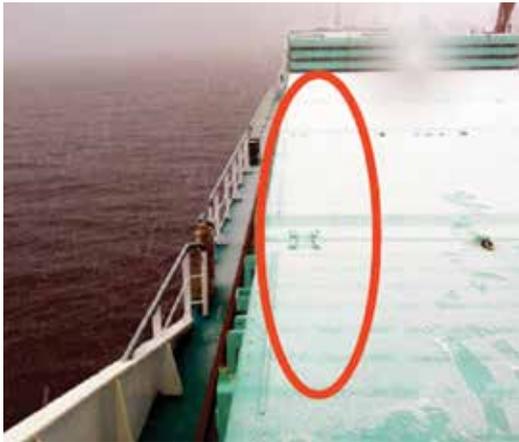
- If in doubt, always opt for more safety rather than less. In this case the safety line was not used because it was thought unnecessary. Two men paid with their lives.
- One of the principal tasks for a MOB incident is getting the ship turned around and back to the incident area in the shortest possible time. If sea room allows, hard helm should immediately be applied (to the side of the fall) and one of several well known turning methods used, as below.

■ **Editor's note:** The Williamson turn is especially useful in reduced visibility as it brings the vessel back on a reciprocal course and into its own wake. However, with good visibility the Anderson turn should be employed as it is a quicker turn.
