CHIRP

Confidential Human Factors Incident Reporting Programme

Danger! Working at height!

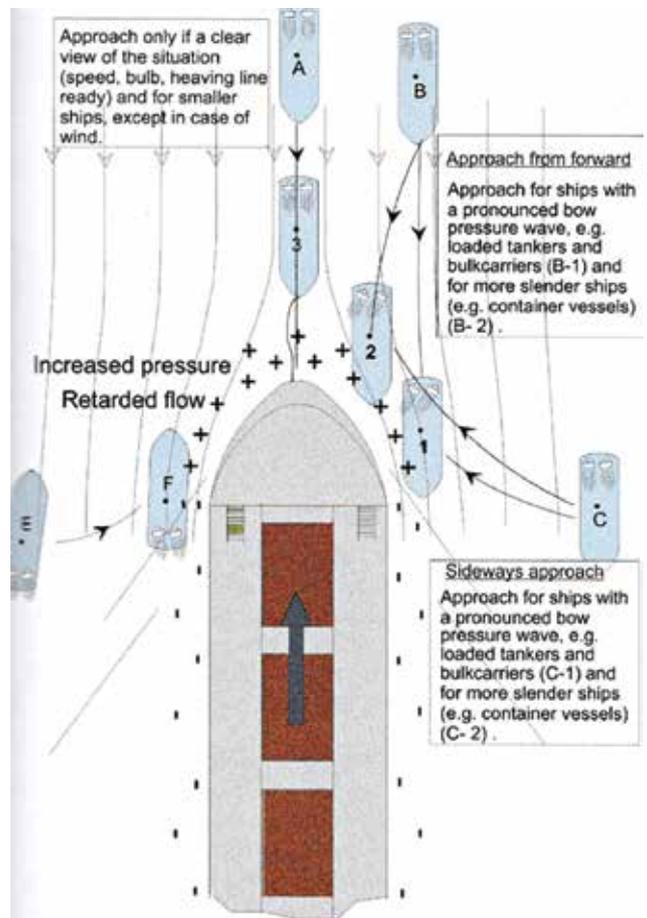
Diagram courtesy of Captain Henk Hensen – *Tug use in port: A practical guide.*

Establishing a tow between a tug and ship should be conducted at as low a speed as practicable in the circumstances and conditions to give the tug greater manoeuvrability and avoid it departing from the "safe zone" where dynamic interaction is less likely to occur.

Ship masters (especially pilot-exempt masters) and tug masters must thoroughly understand the theoretical and practical aspects of safe tug/ship operations.
