MA2017-12

**MARINE ACCIDENT
INVESTIGATION REPORT**

Vessel type and name: Container Vessel MANHATTAN BRIDGE
Vessel number: 142550 (IMO number: 9689615)
Gross tonnage: 152,297 tons

Accident type: Explosion of the Auxiliary Boiler
Date and time: Around 23:04, January 19, 2017 (local time, UTC)
Location: Port of Felixstowe, United Kingdom of Great Britain and Northern Ireland
Around 012° true bearing, 2.0 nautical miles from the Dovercourt High Lighthouse
(approximately 51°57.8'N, 001°17.2E)

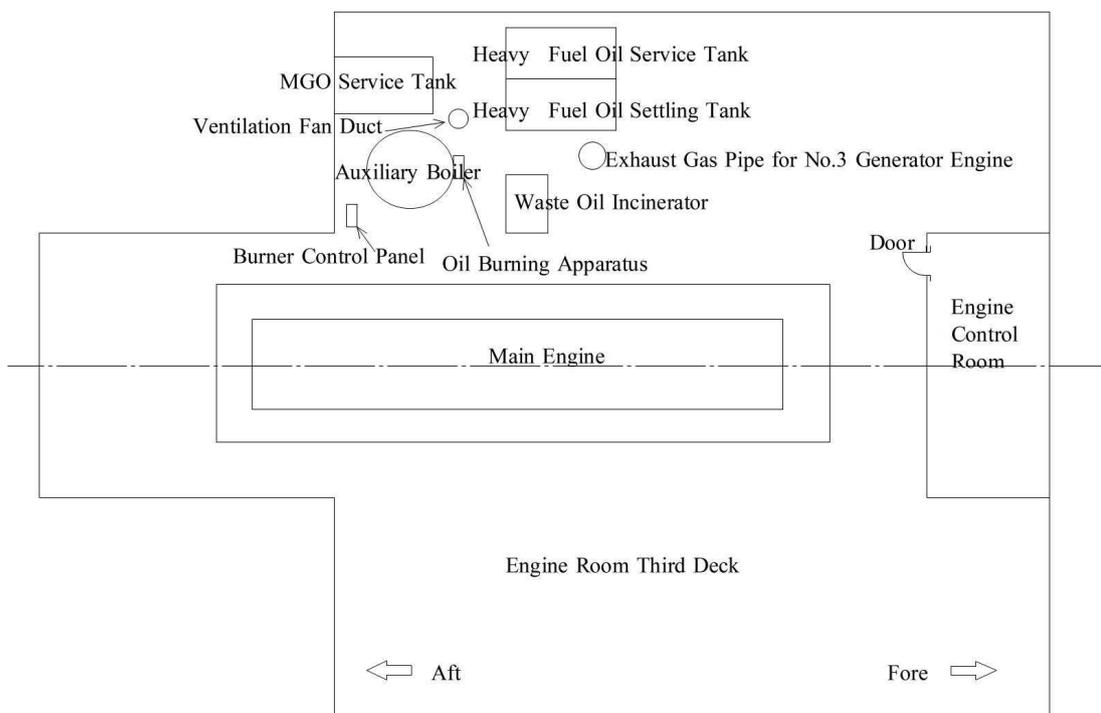
Figure 2.5-1 Engine room third deck

The auxiliary boiler was located on the third deck starboard side in the engine room composed of five decks. In addition, the fuel oil tanks were on the port side of the auxiliary boiler, the auxiliary boiler local control panel was on the aft side of the auxiliary boiler, the waste oil incinerator and the exhaust pipe of the No.3 generator engine were on the fore side of the auxiliary boiler, and the Oil Burning Apparatus was attached to the front of the auxiliary boiler. (See Figure 2.5-1)

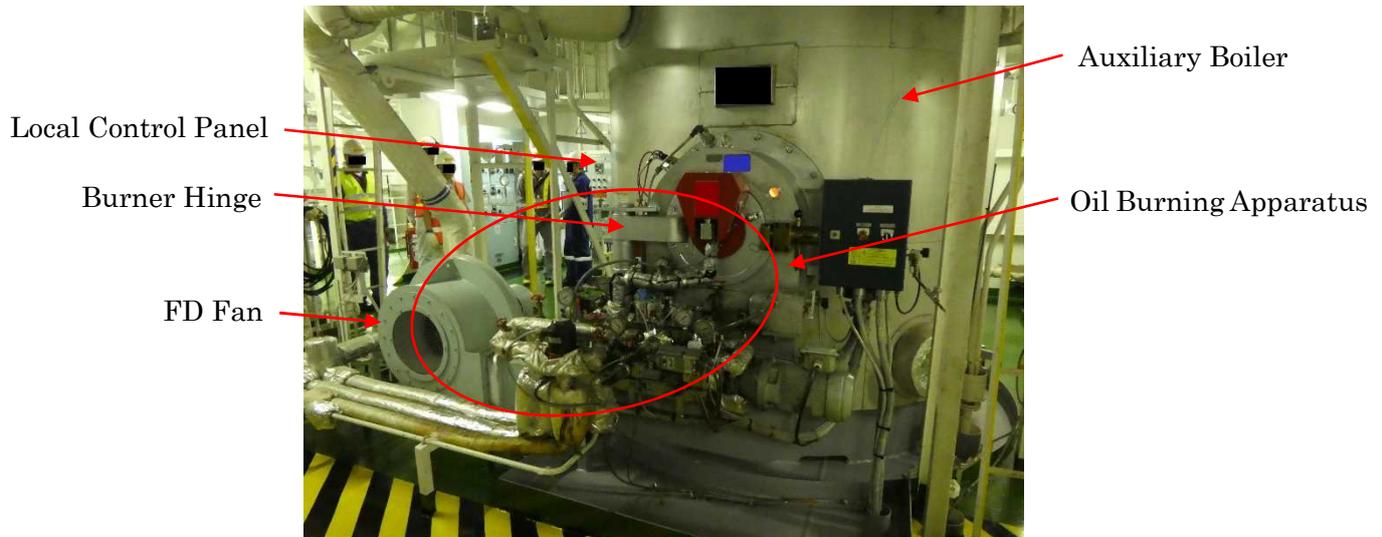
Photo 2.5-2 Auxiliary Boiler

The auxiliary boiler was a vertical oil-fired boiler with an approved working pressure of up to 0.8 MPa and an evaporation rate of 4,000kg/hour. The auxiliary boiler fuel oil supply system enabled heavy fuel oil, MGO and fuel oil / water emulsion*7 to be burnt in the furnace. The auxiliary boiler had the rotary cup burner and the FD fan which supplied combustion air to the furnace. At the time of the accident, the auxiliary boiler used MGO for fuel oil. (See Photo 2.5-2)

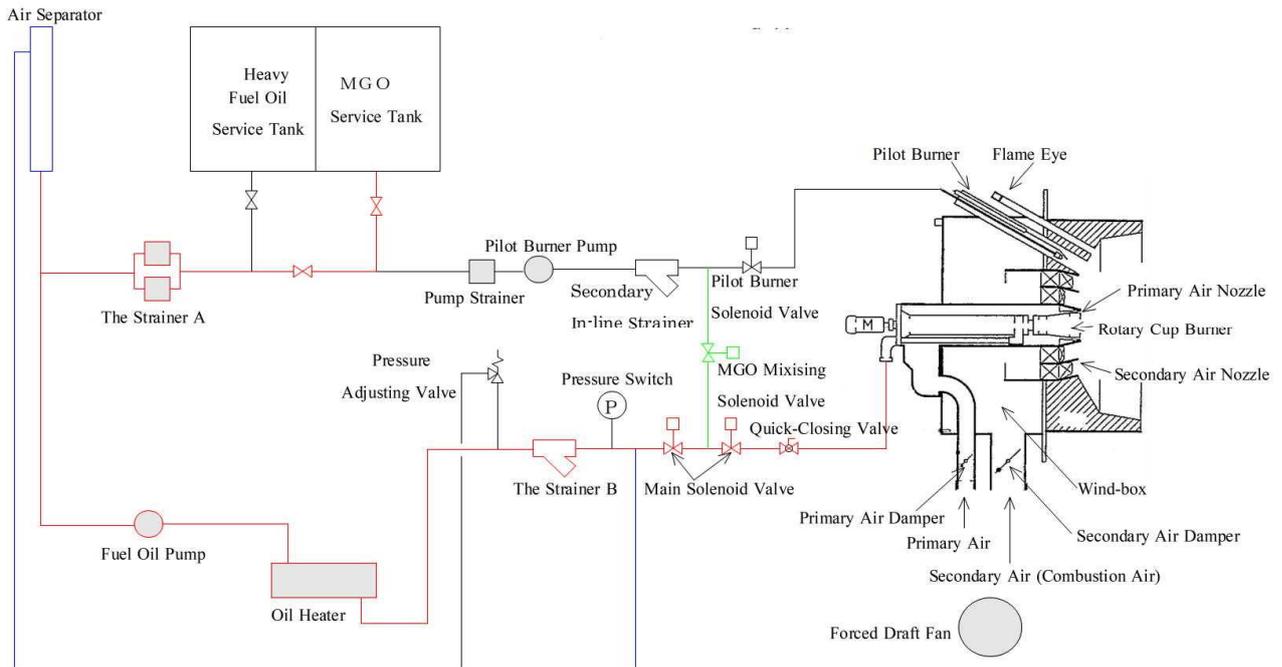
Figure 2.5-2 Fuel Oil Piping

When operating the rotary cup burner on either heavy fuel oil or MGO, the fuel oil was supplied from the respective service tank to the burner unit via a duplex strainer (hereinafter referred to as "the Strainer A"), a fuel oil pump, an oil heater, and the other strainer (hereinafter referred to as "the Strainer B"), two main solenoid valves, and a quick-closing valve.

The pressure of the fuel oil of the rotary cup burner piping was adjusted to be 0.3 MPa by the fuel oil pressure adjusting valve.

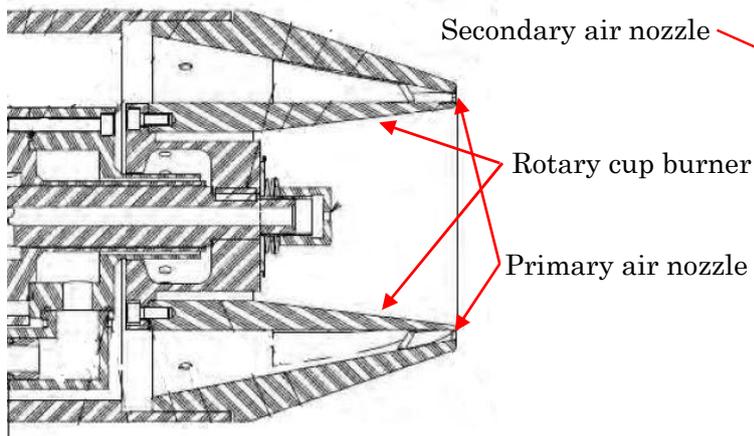
Figure 2.5-3 Rotary cup burner

The fuel oil spread evenly across the inner surface of the taper by centrifugal force and was supplied to the furnace conically by the primary air through the primary air damper and the primary air nozzle surrounding the end of the cup. The combustion in the furnace was started by the fire of the pilot burner. Then, secondary air is supplied by a FD fan to the burner unit through the secondary air damper (hereinafter referred to as “the 2nd Damper”) and the secondary air nozzle. When steam pressure increases higher than the “steam pressure combustion stop” set point (0.65 MPa), the control system initiates a “stop sequence”.

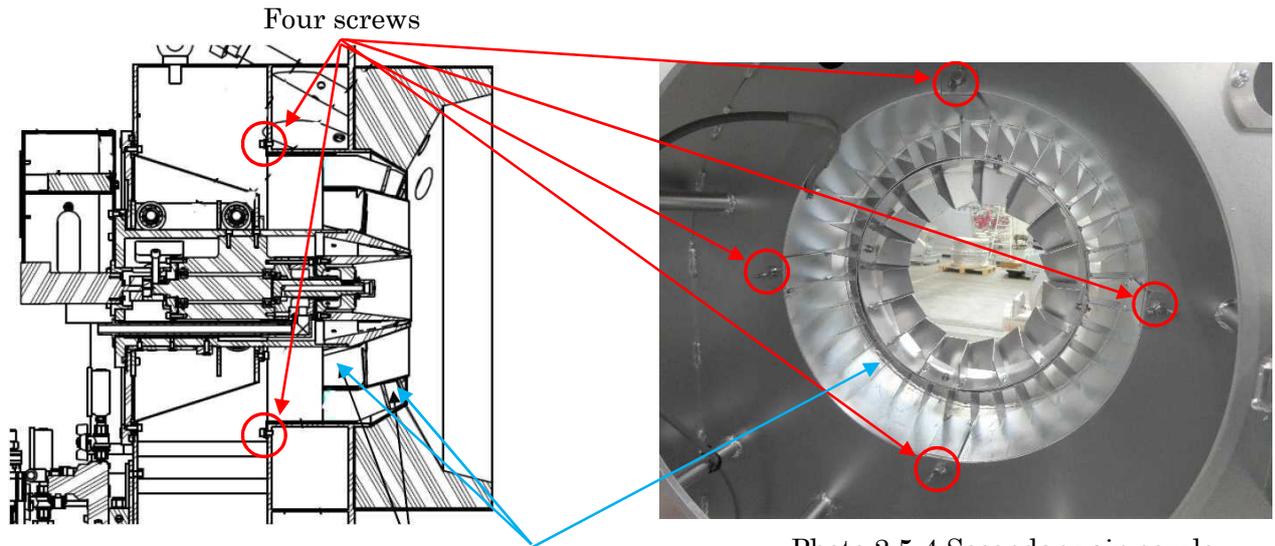
Figure 2.5-5 Cross section of Secondary air nozzle of Oil Burning Apparatus

The secondary air nozzle was equipped to the auxiliary boiler with four screws (M6) so as to cover the burner. (See Figure 2.5-5, Photo 2.5-4)

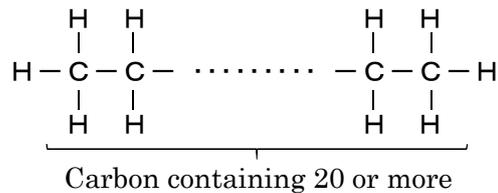
Figure 2.9-1 Paraffin wax composition diagram

According to the reply to the questionnaire by the fuel oil analyze company, paraffin wax was linear hydrocarbons refined from crude oil, and generally contained 20 or more carbon as a main component. It precipitated at low temperatures, and became waxy, strainers were clog with it. (See Figure 2.9-1)

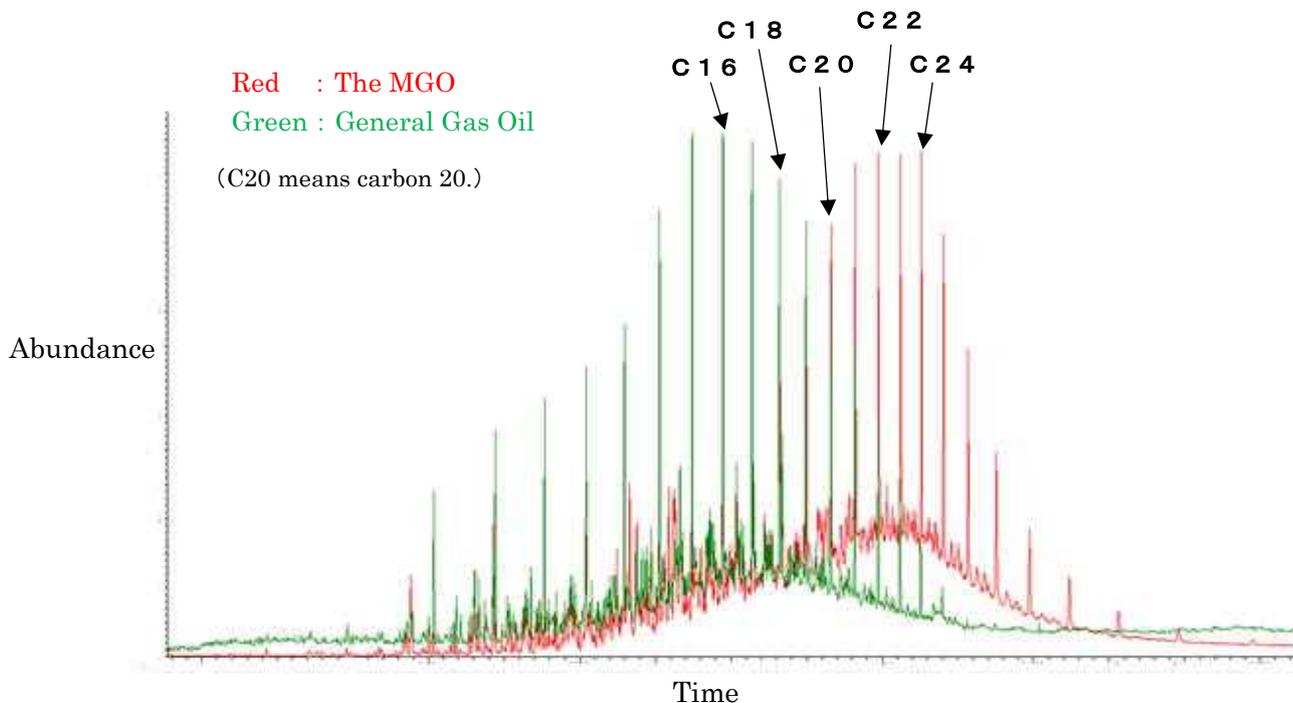
Figure 2.9-2 GC-MS analysis

JTSB inspectors took the MGO samples. These were sent to the fuel oil analyze company and were analyzed Cloud Point*⁹ (CP), Cold Filter Plugging Point*¹⁰ (CFPP), Pour Point*¹¹ (PP) and Gas Chromatography-Mass Spectrometry analysis*¹² (GC-MS analysis). In addition, these were analyzed the Cloud Point, Cold Filter Plugging Point and Pour Point when adding the Cold flow improvers which was held by the Vessel to MGO. The test results were shown as Table 2.9 and Figure 2.9-2.

Cloud Point	19 °C	18 °C
Cold Filter Plugging Point	12 °C	5 °C
Pour Point	-10 °C	-10 °C
