# Seaways

# Mariners' Alerting and Reporting Scheme

MARS Report No. 254 December 2013

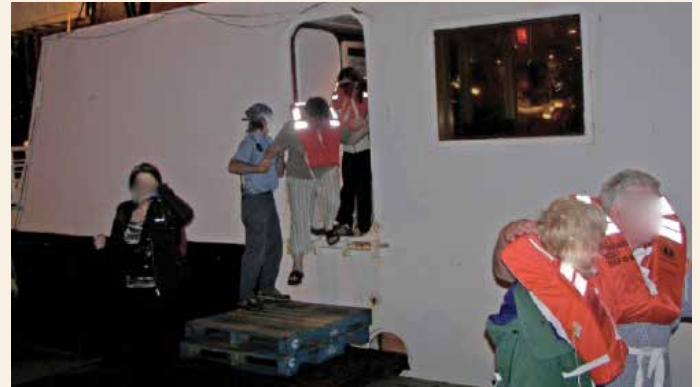
➔ A small coastal vessel on a scheduled route carrying passengers and cargo to several isolated settlements was proceeding at night towards one of the port stops of the route. A series of events in the wheelhouse

conspired to cause the vessel to sideswipe one of the outlying islands near the port. Within a very short time the vessel was listing heavily to starboard due to water ingress in several tanks.

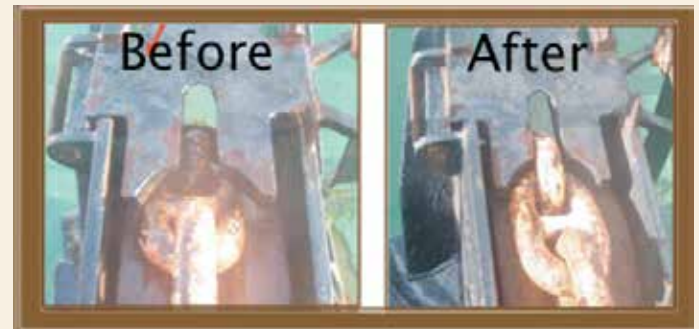
Missing starboard anchor

although lashed and secured with turnbuckle, was not fully resting on the chain stopper. This is supported by the fact that the anchor had been found loose some time earlier and the turnbuckle was re-tightened. If the anchor was fully housed and properly resting on the stopper, the lashing would not have been found loose. So the anchor, hanging slightly, was subject to heavy movements due to bad weather. This caused the pin of the D-shackle to be lost, resulting in the loss of anchor.

■ **Editor's note:** While it is indeed important to have the anchor chain snug to the stopper, all other gear such as the turnbuckles should also be snugged up so as to hold the anchor fast against the anchor pocket

After the incident, corrective action was taken such that the anchor chain was properly resting on the stopper when the anchor was in the fully stowed position. Also, the locking pin on the D-shackle has been welded to avoid accidental release.
