# Seaways

# Mariners' Alerting and Reporting Scheme

MARS Report No. 281 March 2016

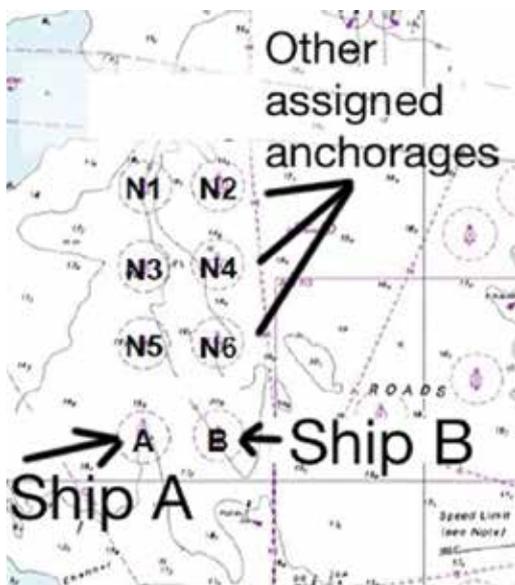
➔ Several ships were at anchorage awaiting berthing space in port. In the early morning, squalls and rain passed across the anchorage and the weather was otherwise stormy with a west-northwest wind at 20+ knots. As a squall with wind gusts up to 56 knots moved across the

anchorage, the increased noise from the wind and rain woke the Master of vessel A. He called the bridge and the OOW confirmed they were maintaining position.

At about the same time the OOW on the vessel at anchorage B observed on radar that ship A was moving towards his ship. His calls to ship A on VHF went unanswered. He next attempted to attract the attention of the OOW on ship A by sounding his ship's whistle. The OOW on ship B then phoned the Master and sounded the ship's general alarm.
