# Seaways

# Mariners' Alerting and Reporting Scheme

MARS Report No. 298 August 2017

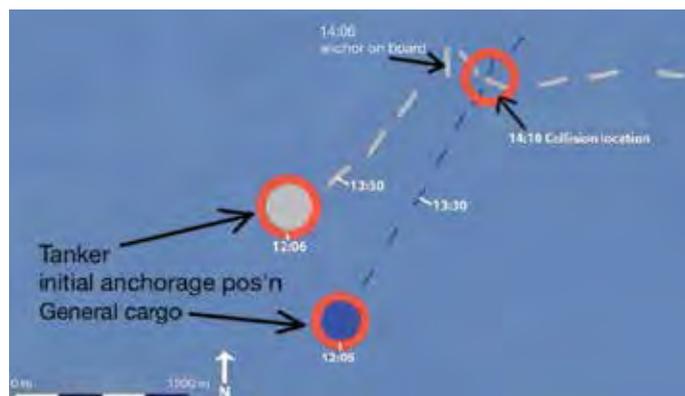
Damage to the general cargo vessel

In the ensuing hours, each of these vessels dragged anchor in a northeast direction, becoming closer to each other. Eventually, the Master of the tanker decided it was prudent to heave anchor. Once the anchor was on board the vessel was swung to port towards the general cargo vessel with the intention of sailing clear. Because the tanker was in

ballast and had hardly any speed, manoeuvring was hampered and the vessel's movement was greatly affected by the strong wind and current, now acting fully on the vessel's starboard side. The tanker was driven into the bow of the general cargo vessel - which was still anchored, but dragging - causing major damage to both vessels.

- Vessels proceeding at low speeds, especially those in ballast condition, are greatly affected by wind and current.
- By stemming forces acting on your vessel you can maintain better control at low speeds.

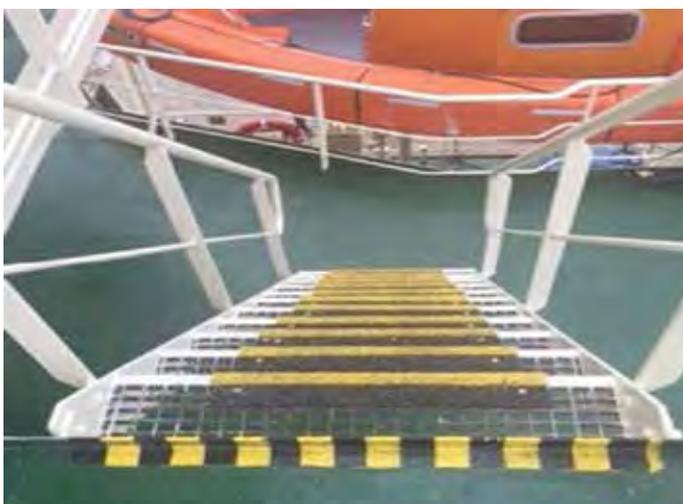
→ A crew member left the bridge and was making his way down the external stairway to the boat deck. During his descent he fell down the stairs to the deck below, fracturing his left forearm.

On investigation, it was determined that the stairs were in good condition and had been fitted with grips. The victim was wearing all appropriate PPE including his safety footwear, which was in good condition.

- Even the best defences (in this case good PPE and stairs with grips) are not always sufficient to compensate for inadequate technique.
- Transiting steep stairs calls for using both hands on the railings; put yourself first!

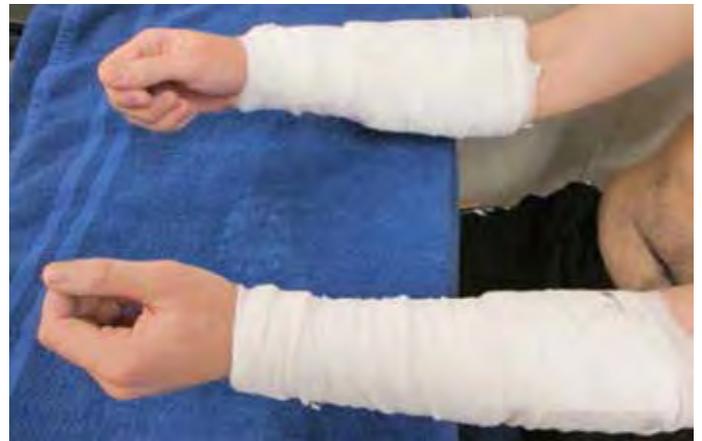
→ A recently qualified crew member was on his first trip as 3rd engineer and had only a few days experience as the sole engineer of the watch (EOW). Keen to clear the outstanding planned maintenance, he asked the engine room cadet to complete the job of topping up the cooling system on one of the four main engines. This was a job the cadet had previously done, but only on an engine that was not running. In this instance, the engine was running and on-line.

The engine had both a lower and upper temperature header tank and both required topping up. As the cadet removed the cap from the upper temperature header tank, water at 90°C and 7 psi was released spraying across both of his forearms. First aid was quickly administered but the mishap resulted in 2nd degree burns to both of his arms. The vessel diverted to a nearby port and the cadet was released to the local hospital before he was repatriated home.

- When you are new to a job, don't hesitate to ask superiors for their input before undertaking a task.
- Before undertaking a task, do a running risk assessment. Ask yourself, 'What could go wrong?'
- Never carry out maintenance on running or standby machinery. Do the lock-out tag-out (LOTO) procedure first.
- All crew, irrespective of their rank, have the same authority and responsibility to stop a job if they are unsure of safety.

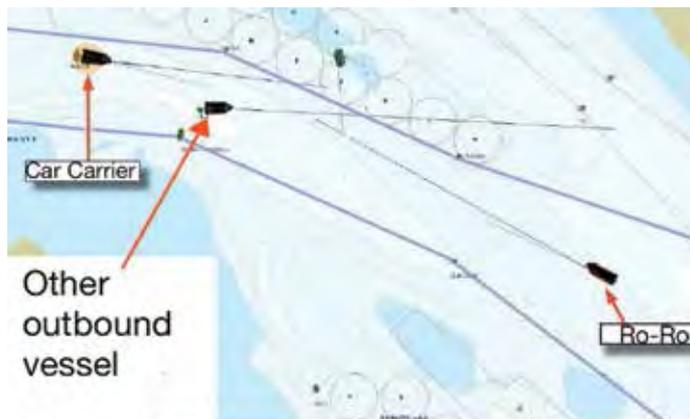
→ In darkness and under pilotage a car carrier was outbound in a river estuary behind another outbound vessel. The car carrier was to the north of the channel and of the intended track. The pilot informed the Master that he would try and manoeuvre the ship further to the south. At the time an approaching vessel, an inbound ro-ro ferry, was in clear sight. The pilot of the car carrier informed the Master that they would pass the ro-ro port to port.

When the two vessels were 2.8nm apart the car carrier was making 12kts and the ro-ro near 16kts; they would meet in six minutes. The ro-ro's Master and second officer were concerned that the car carrier remained on the northern side of the channel and did not appear to be altering course to the south. The VTS watch manager was also concerned; both he and the ro-ro's second officer called the car carrier in quick succession on VHF to inquire as to its intentions.
