Safer Seas 2013

LESSONS LEARNED FROM MARINE
ACCIDENT INVESTIGATIONS

Office of Marine Safety Investigations

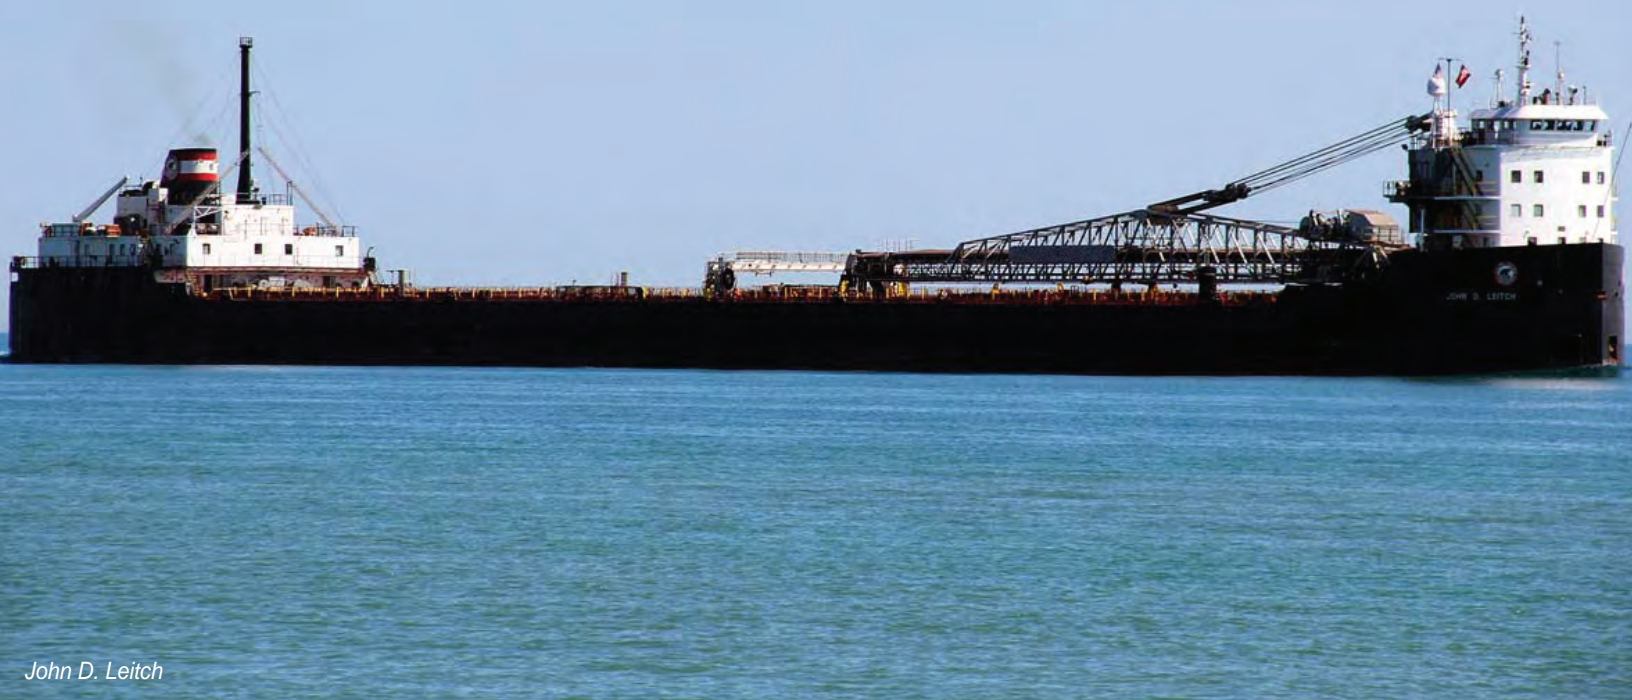
John D. Leitch

As the vessel's bow cleared the bridge supports on the channel's east side, the master noticed that the bow was not swinging to port as intended, so he applied more engine thrust and pitch to the vessel's propeller but with no effect. The master had allowed the stern of the vessel to transit close enough to the west bank of the channel that the stern was influenced by bank suction. As a result, the stern was pulled toward the west bank and the vessel's bow sheered to starboard, toward the east bank where the Lorrain County Sheriff's Office (LCSO) law enforcement vessel was moored at Coast Guard Station Lorain. At 1912, the forward starboard bow of the *John D. Leitch* made slight contact with a piling structure and the sheriff's office vessel.

- *John D. Leitch*: Small scrapes along portions of the forward starboard hull, with no plate inset.
- LCSO NBI vessel: Total damages exceeded \$500,000.

The National Transportation Safety Board determines that the probable cause of the allision was the failure of the master of the *John D. Leitch* to properly account for bank effect while maneuvering in the confined waters of the Black River.

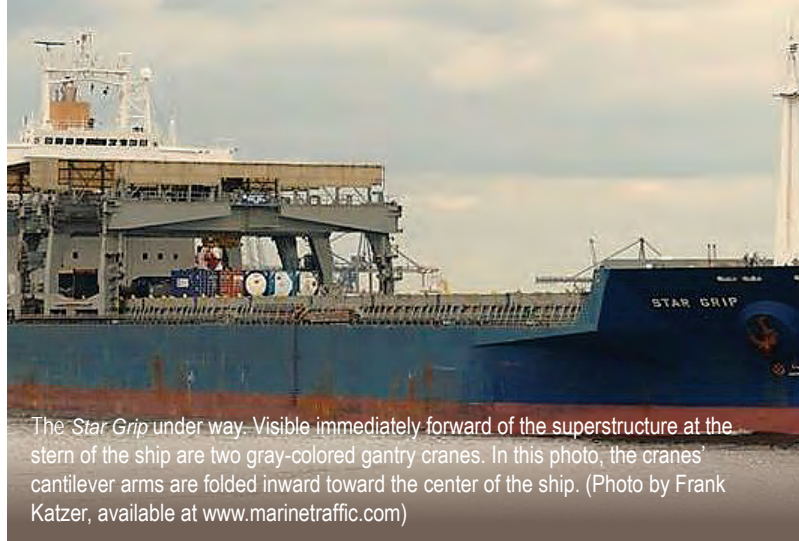
The *Star Grip* under way. Visible immediately forward of the superstructure at the stern of the ship are two gray-colored gantry cranes. In this photo, the cranes' cantilever arms are folded inward toward the center of the ship. (Photo by Frank Katzer, available at www.marinetraffic.com)

The National Transportation Safety Board determines that the probable cause of the collision between bulk carriers *Mary Ann Hudson* and *Star Grip* was the pilot's ineffective handling of the *Mary Ann Hudson* and his ineffective use of the two tugboats to maneuver the vessel around the *Star Grip*'s crane arms, which were extending into the navigable waterway.

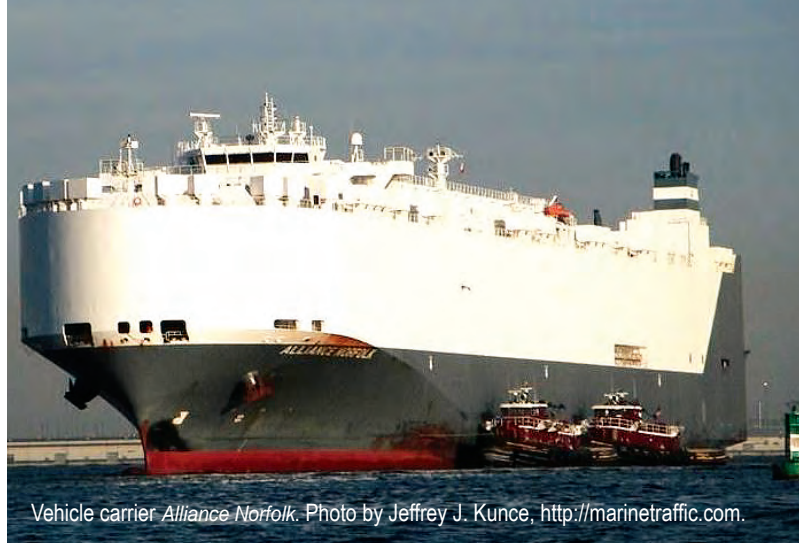
Coast Guard investigators could not determine the initial source of ignition. However, the dynamic environment of the vessel rolling in heavy seas and shifting cargo in the presence of various flammable liquids (held within the mixed cargo and containers) could have produced an ignition source.

The National Transportation Safety Board determines that the probable cause of the fire on board the *Alliance Norfolk* was ignition of flammable material by an undetermined ignition source on deck 5 due to shifting cargo while the vessel was rolling in heavy seas after losing power. Contributing to the severity of the damage was the reflash of the smoldering fire when the vessel was in port.

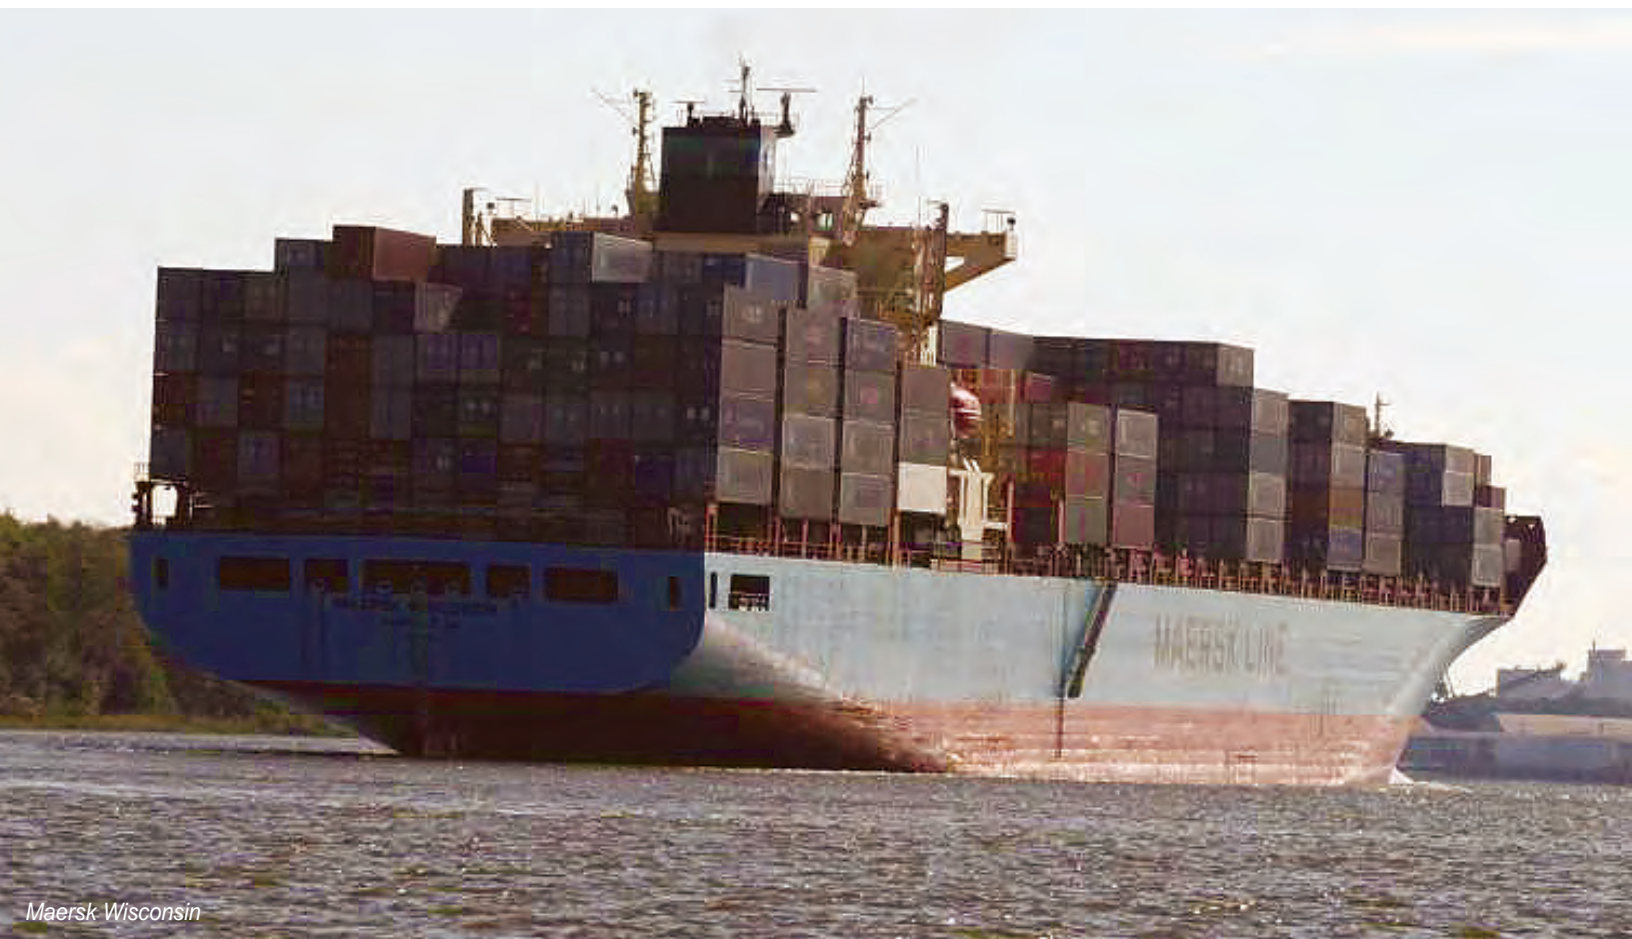
Maersk Wisconsin

level and sustained side shell plate damage and upset of internal framing. Some frame and plate damage was also noted in a cargo tank. The bow of the *Maersk Wisconsin* sustained shell plate damage and was holed about 23 feet above the waterline. Internal framing of that compartment was also distorted.

The National Transportation Safety Board determines that the probable cause of the collision was the failure of the docking pilot on board the *Maersk Wisconsin* to position his vessel according to the meeting arrangement with the *Ruth M. Reinauer* to allow adequate separation for passage of the tug and barge in the navigable channel.

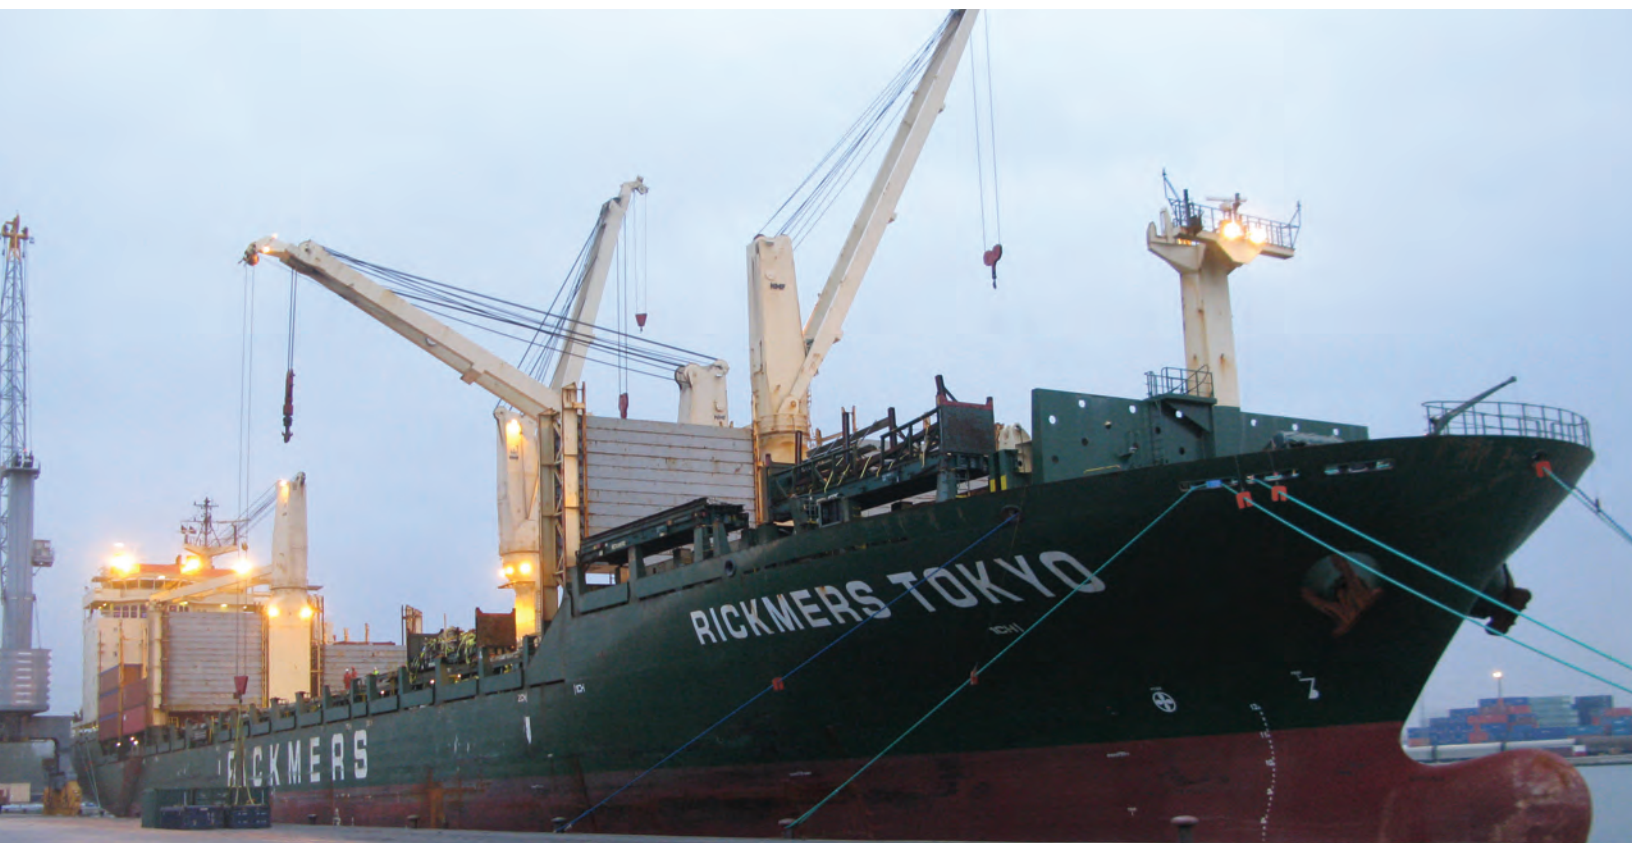
Rickmers Tokyo

By 1938 the crew reported to the master that the vessel had a large hole at the waterline and had ruptured a ballast tank. The master wanted to anchor, and the river pilot suggested the Marcus Hook Anchorage below downtown Philadelphia. At 2205, the vessel anchored at this location, about 22 miles from the allision, and the river pilot disembarked the vessel.

The National Transportation Safety Board determines that the probable cause of the allision of *Rickmers Tokyo* with Pier 11 in the Delaware River was the river pilot not executing the turn at Port Richmond due to his lack of situation awareness regarding the vessel's position in the channel and his inadequate use of all available navigation equipment. Contributing to the allision was the river pilot's failure to wear his corrective eyewear, which was required and would have assisted with distant visual cues on the dark evening.

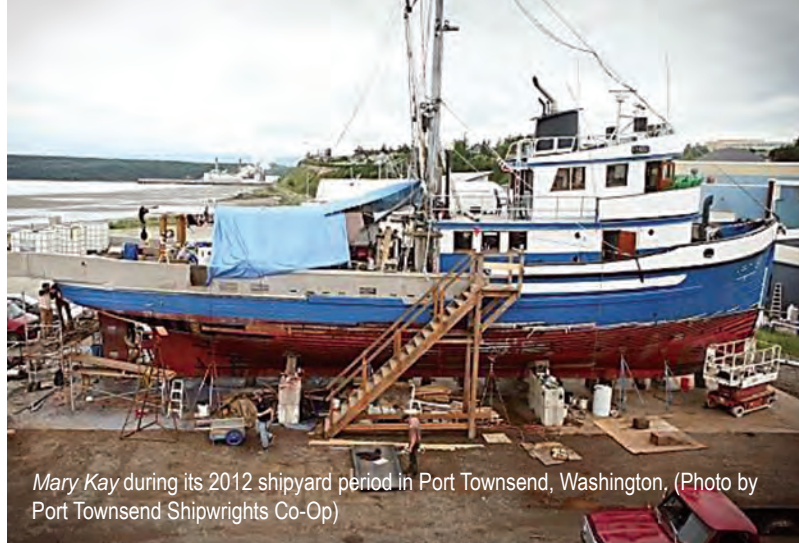
Almost a month earlier, on July 1, 2012, the *Mary Kay* had returned to service following a 3-month shipyard period at Port Townsend, Washington. During this time, extensive modifications were made, which included adding a third fish hold, replacing wornout bottom planking, removing a hydraulic bilge pump, and installing a refrigerated sea water circulation pipe. The addition of the third fish hold nearly doubled the vessel's capacity and likely changed its center of gravity.

When the *Mary Kay* departed the Port Townsend shipyard facility on July 1, 2012, the vessel returned to service without a sea trial. After getting under way toward the first scheduled stop of Bellingham, Washington, the crew detected a leak on the bottom of the starboard fish hold and another leak in the lazarette. On arriving in Bellingham, the *Mary Kay* lost operational control and consequently allided with a dock in port. The damage to the hull of the *Mary Kay* was not investigated, perhaps because the estimated damage was less than the required reportable amount.

Mary Kay during its 2012 shipyard period in Port Townsend, Washington. (Photo by Port Townsend Shipwrights Co-Op)

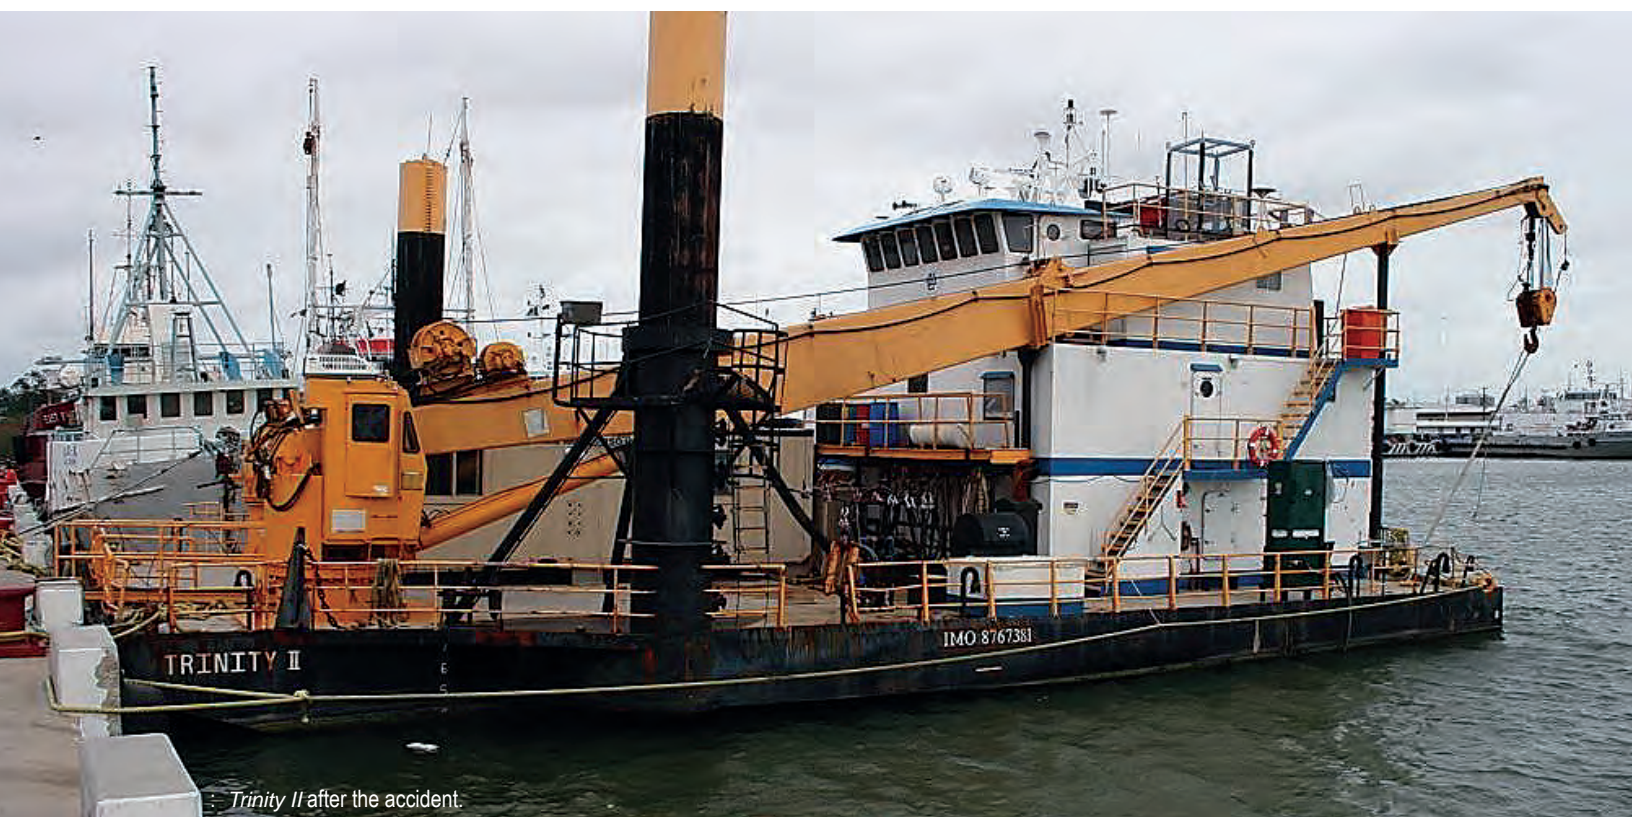
The total damage to the *Trinity II* was estimated to be \$1.5 million.

: *Trinity II* after the accident.

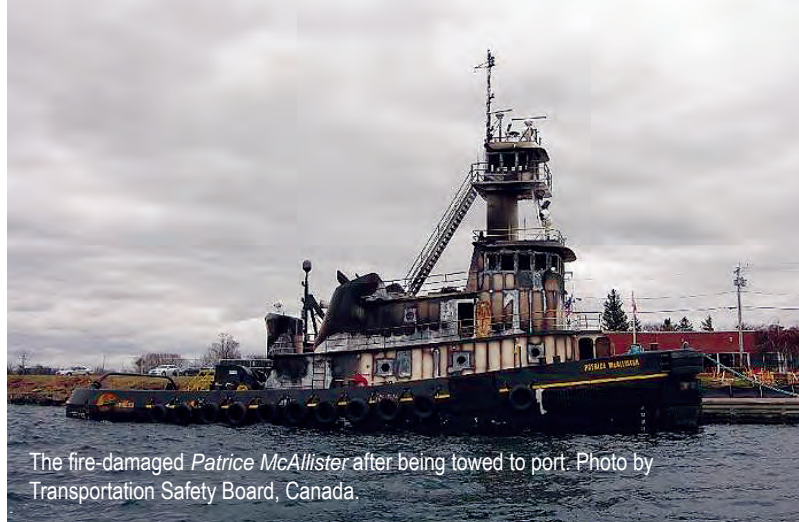
About 0229, a small hairline fracture in the port engine's prelubrication oil pump discharge line began spraying lubrication oil into the engine room. The oil spray made contact with the hot portside engine manifold and flashed into an oil spray fire.

engine room near the smokestack. Because the ladder was in the path of the oil spray fire, the chief engineer had to exit through the fire, igniting his clothing. He collapsed on deck after exiting. The other crewmembers, who had been alerted to the fire moments earlier by heat and smoke coming through a galley range hood vent, discovered the chief engineer and extinguished the flames in his clothing. The chief engineer suffered burns on more than 90 percent of his body. The oil spray fire also ignited combustible material on the fiddley deck.

The National Transportation Safety Board determines that the probable cause of the engine room fire on board the *Patrice McAllister* was the ignition of lubricating oil that sprayed from a fatigue-fractured fitting on the portside main engine's prelubrication oil pump onto the hot surface of the portside main engine's exhaust manifold. Contributing to the extent of the fire damage was the crewmembers' compromise of the fire boundaries when they prematurely began desmoking the vessel's superstructure, the inability to completely secure the engine room's fire boundaries, and the abundance of flammable material throughout the vessel.
