News 25 Jul, 2019

## **Engine Room Fire Safety - Condition survey findings**

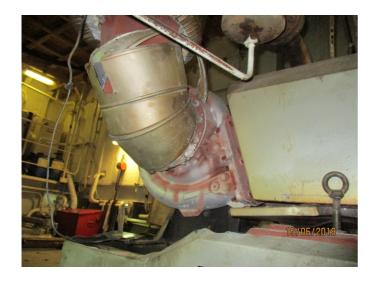
Primary sources of ignition in the engine room include hot exhaust manifolds of engines, boilers and indicator valves of the engines. When flammable liquids leak on, splash over, or are sprayed onto an exposed high temperature surface they can auto-ignite. Reportedly up to 70% of all engine room fires are set off by fuel leaks. SOLAS Ch II-2 Reg 4 para 2.2.6 requires that surfaces with temperatures of 220°C and above must be properly insulated.

Exhaust gas casing, indicator valve shields and lagging degrade with time due to vibration, repeated heating and cooling down or disassembly and refitting during maintenance. The crew must make sure that high temperature surfaces are adequately protected at all times when there is a risk of flammable oils being sprayed over the surface.

Damaged and missing insulation of the engine exhaust gas turbocharger and uptakes

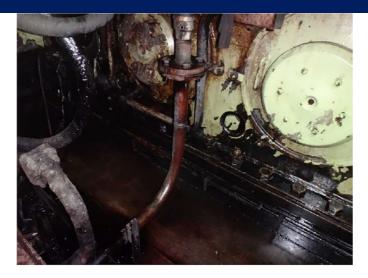
#### Oil stained engine entablature

Dirty bilges, stained engine entablature and makeshift solutions such as leak collectors and plastic hoses may be set on fire by hot work such as welding or grinding. These will also provide an additional source of fuel to sustain and spread an engine room fire. Proper housekeeping along with the timely identification and elimination of oil leaks are of utmost importance for the prevention of fires in engine rooms.
