## **Loss Prevention Bulletin**

# Natural Fibre Rope Ladders - Care and Maintenance

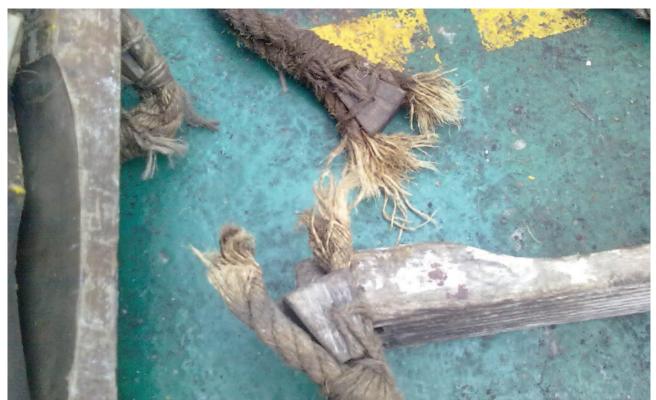
Photo: TC

A pilot ladder side rope which failed as a pilot climbed the ladder

Any damage to or degradation of a natural fibre rope ladder should be evaluated by an appropriately experienced crewmember. If deemed necessary, or if any doubt exists, the ladder should be removed from service and repaired or replaced. Factors which may result in such action may include:

If small sections of rope are found to be damaged or weakened, the entire length should be replaced completely. It

is not acceptable to crop out the affected areas and reconnect the rope regardless of the method used (eg splicing, joining shackles, knots).

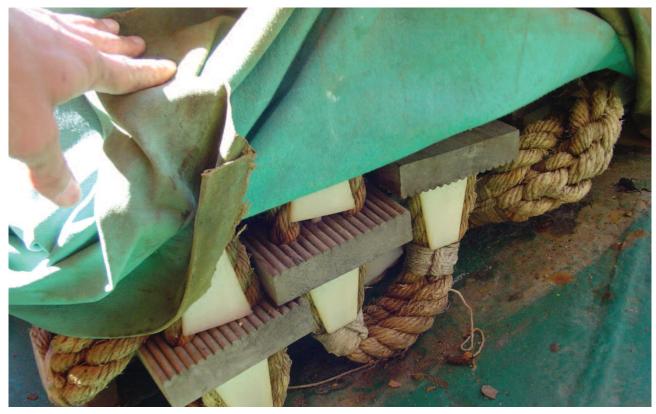
An embarkation ladder resting on deck exposed to attack by water and cleaning chemicals

In order to protect rope ladders stored outside from the effects of rot, mildew, chemicals, acids and detergents, they should be stowed on a suitable grating. Wooden pallets, cut down to size, are ideal for this purpose. The height of the grating should be such that the ladder will not come into contact with free water on deck that may contain potentially harmful products.

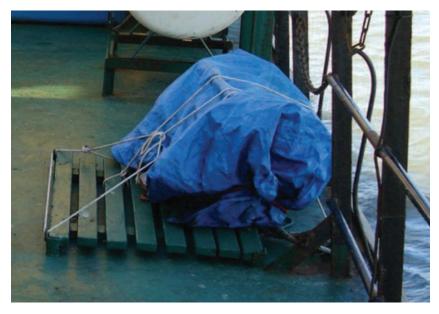
An embarkation ladder stowed clear of the deck and suitably covered

Natural fibre rope is also susceptible to actinic degradation due to ultraviolet radiation, particularly in tropical areas. Rope ladders stored outside should therefore be covered when not in use to protect them from the effects of sunlight. Coverings will also protect ladders from precipitation and frost.
