# Safety Alert

SA 011

## Zinc Concentrate from Bar, Montenegro

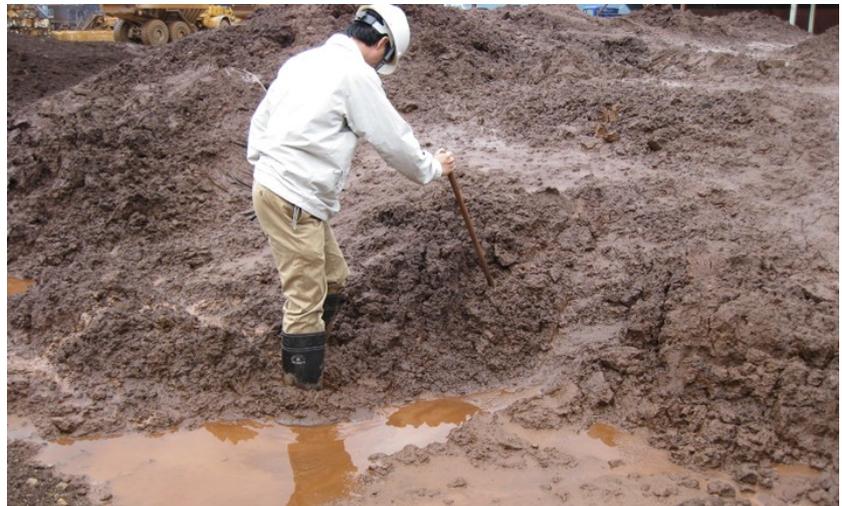
The spoil heaps have never been protected from precipitation and tests in the past have shown the material to have a moisture content of up to 31%, exceeding the Transportable Moisture Limit (TML) by a considerable margin.

By way of example, a vessel due to load zinc concentrate at Bar was recently presented with cargo documentation in accordance with IMSBC Code requirements indicating that the product was safe to carry. However, can tests indicated otherwise and the visual appearance of the cargo was that of wet mud. Samples were then sent to an

**Typical appearance of zinc concentrate presented for loading in Bar, Montenegro**

independent laboratory in the United Kingdom which confirmed that the moisture content of the product was significantly higher than the TML and consequently prone to liquefaction.

It is rumoured that a drying plant may be installed at Bar at some stage in the future. In the meantime Members are advised to contact the Managers before fixing a vessel to load zinc

concentrate or zinc oxide from Bar for news of any developments.

Members already committed to such a fixture should notify the Managers without delay as it will be necessary to appoint a local surveyor to take samples of the cargo prior to arrival and arrange for them to be sent to a reliable laboratory so that an accurate determination of the TML and moisture content can be made. Since it appears that there are no laboratories in Montenegro equipped with a suitable flow table, samples will need to be sent to an independent laboratory elsewhere in Europe. This may take several days. However, based on past experience the tests are likely to show that the moisture content exceeds the TML and that the cargo cannot be loaded.
